Existing Conditions Assessment

Casparus F. Pruyn House

207 Old Niskayuna Road, Town of Colonie, Albany County, New York

September 2016

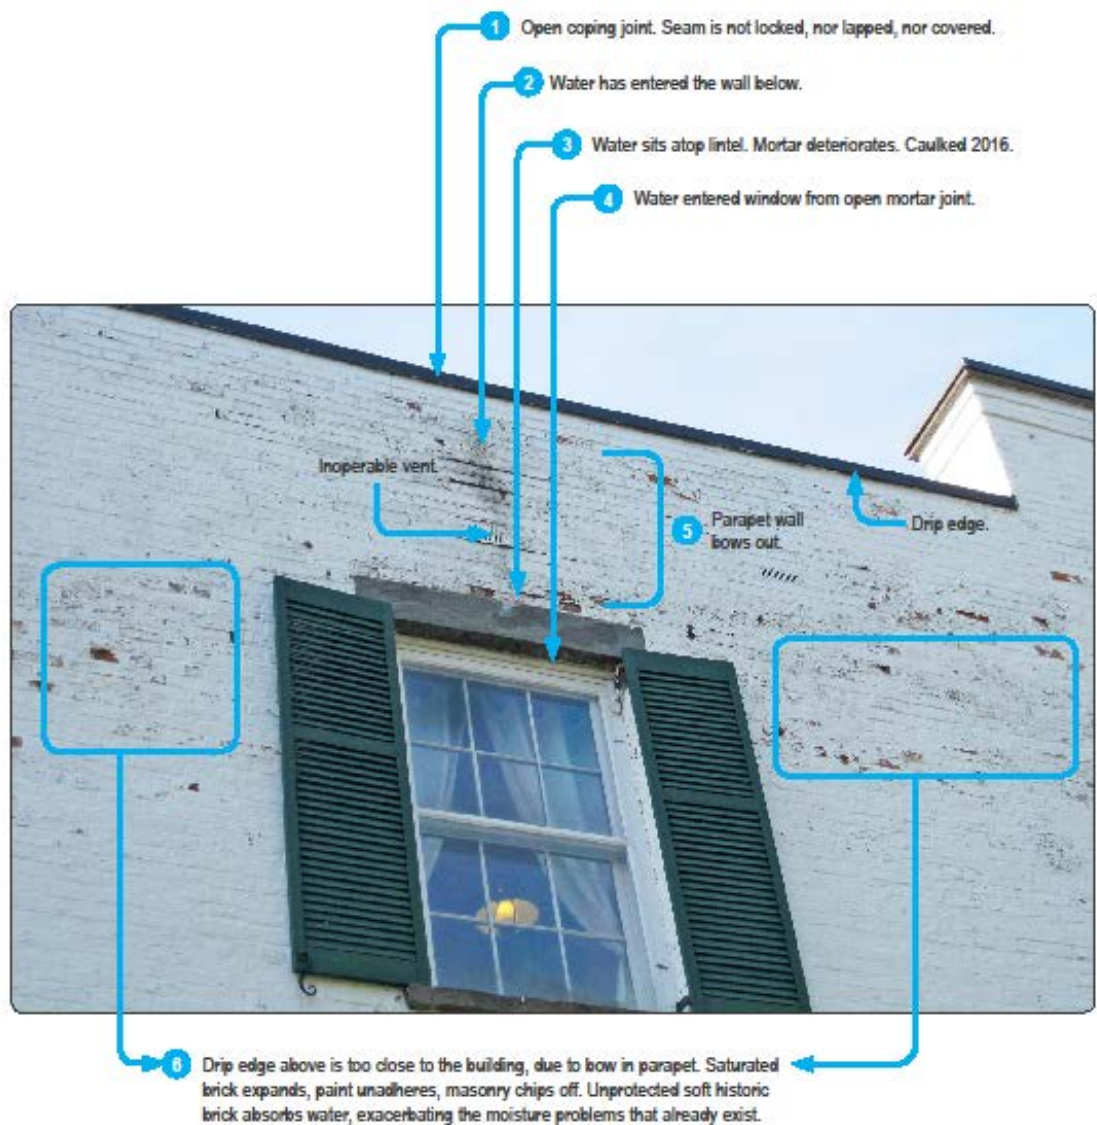
Figure 1. Illustration of water related problems at second floor parapet, north elevation.

Substantial brick repair and reconstruction to solve water problems has occurred on the north elevation above the second floor window level in the past 30 years, without success. The north elevation suffers from driving rains and winds, with its northwest frontage. This is evidenced by its condition, which is worse than any other elevation. At its parapet, the brick is bulging and cracking, because it gets washed by water from the failed coping and drip edge above. This water continues downwards into the second story window head, and into the interior of the building. A more detailed explanation is provided in Figure 1.

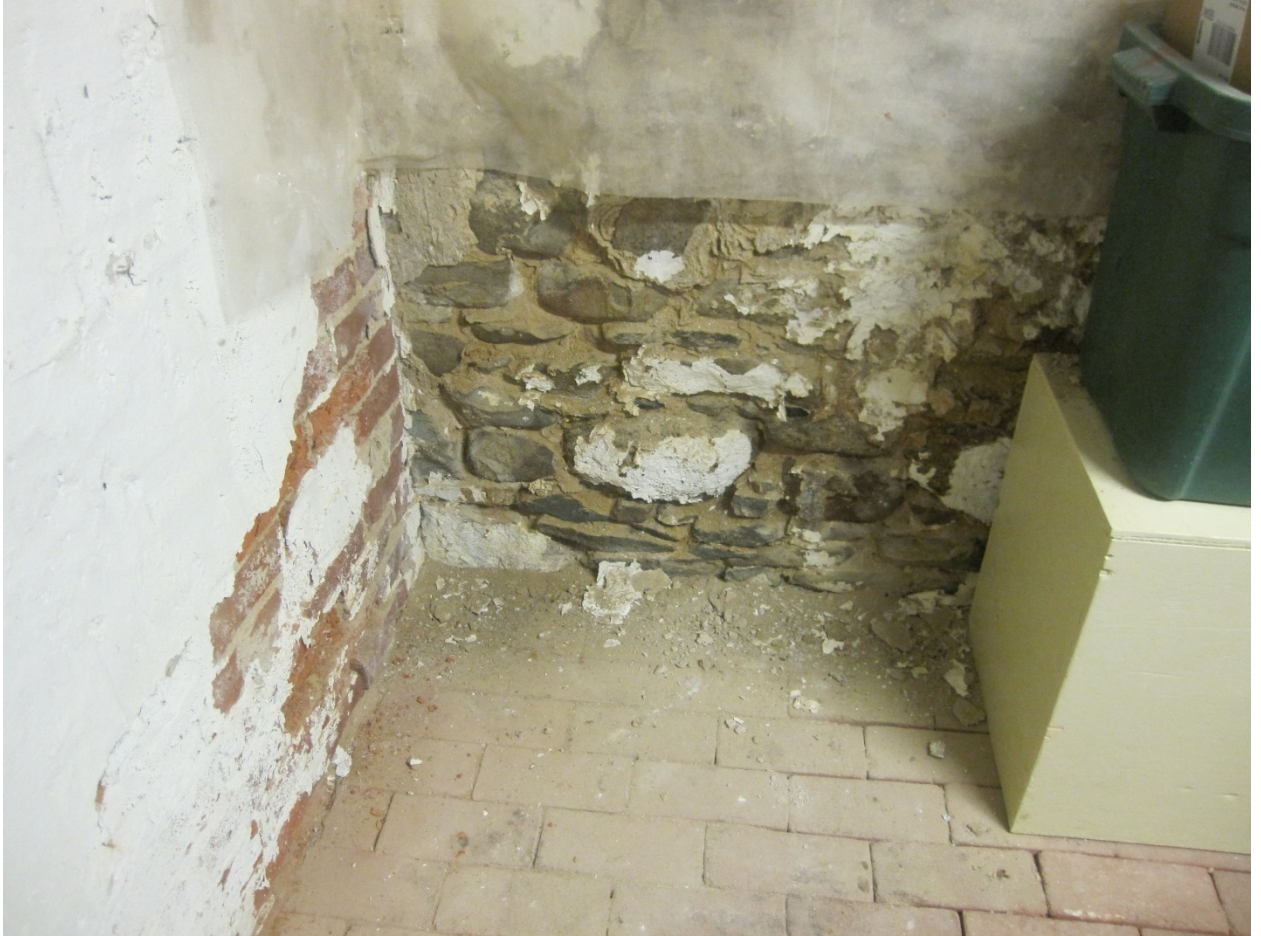
Figure 2. Interior face of west elevation foundation.

Stone Walls: At the west foundation wall, one of the few locations where the stone is exposed, plastic was installed over the upper portion of the wall in 1984 during the renovation as the crumbling mortar was depositing sand onto the floor. The plastic sheet has remained in place since, trapping moisture behind it. There is evidence of historic whitewash on the stone, though most of it has powdered off. Mortar has also disintegrated drastically, leaving piles of sand sitting on the floor adjacent to the foundation (Figure 2).

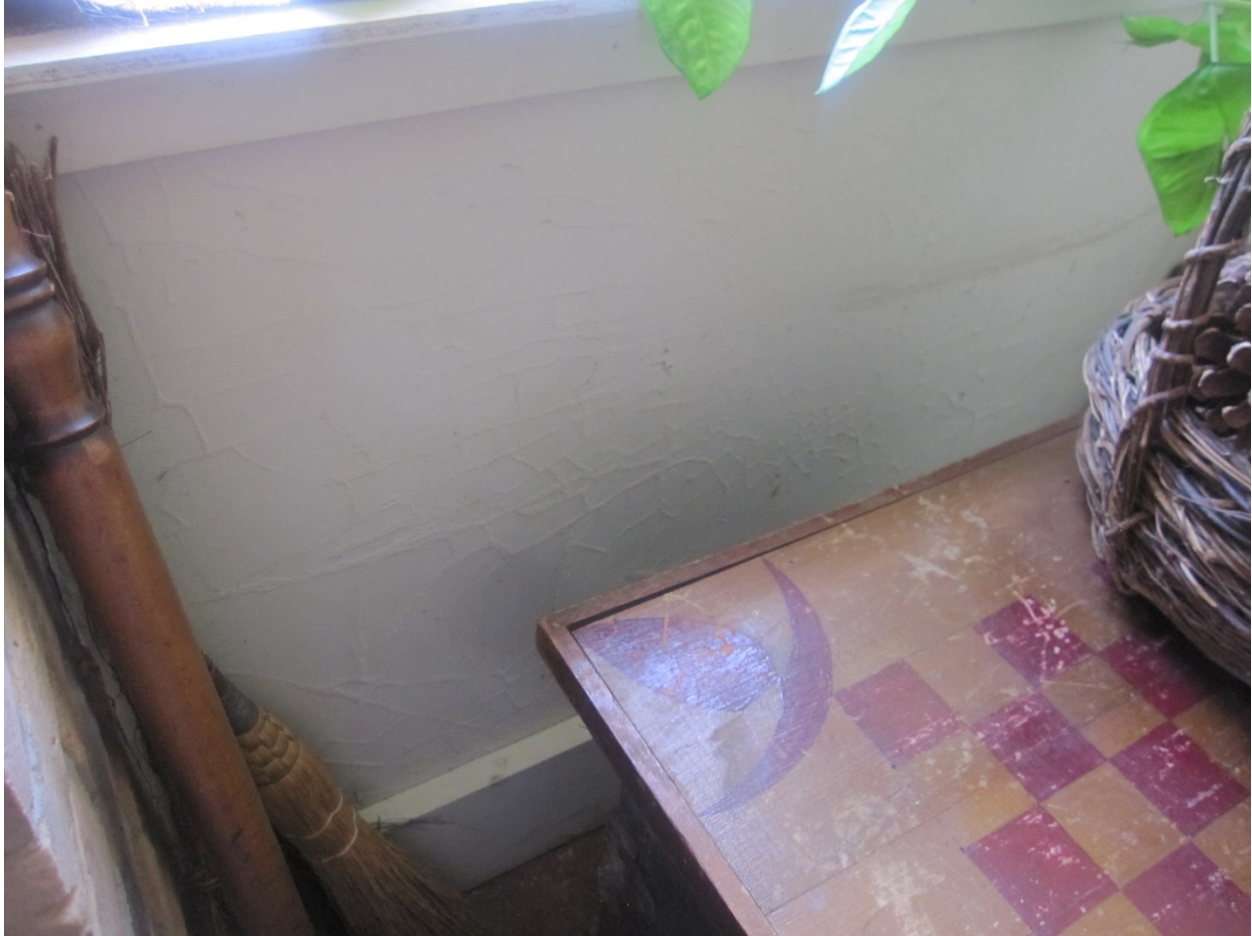
Figure 3. Lower wall, northeast corner of basement.

Furred Out Gypsum Walls: Most of the perimeter foundation wall has been built out. Peeling and/or cracking paint is typically located around windows, especially at the wood aprons below them (Figure 3).

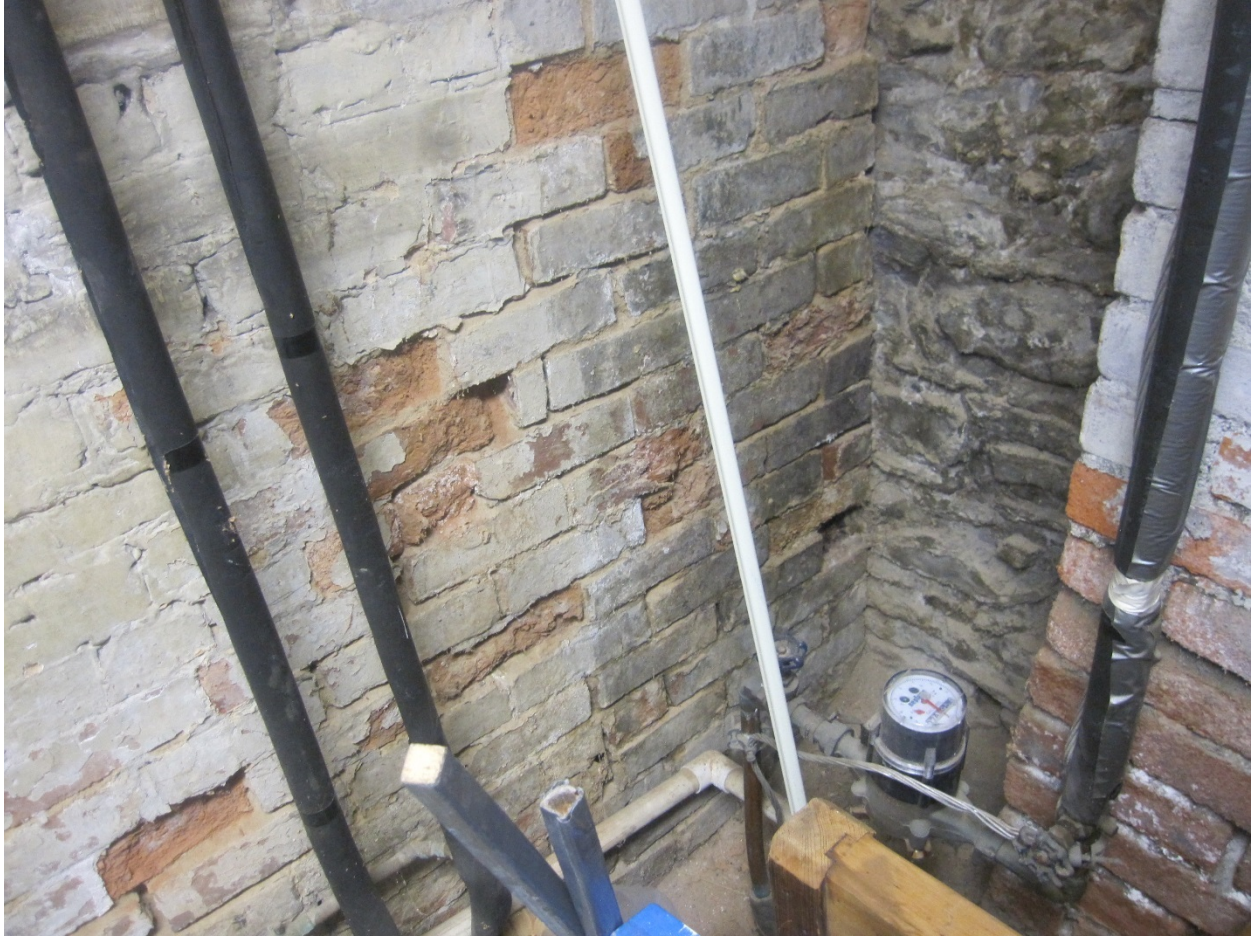
Figure 4. Southeast corner of the Furnace Room.

Brick Walls: The brick wall in the equipment room is in worse condition than the other brick walls. Earlier furnace equipment, and the moisture it gave off, are to blame (Figure 4). Not only is there loss of paint and mortar, but in this case, loss of the brick face itself. A brick chimney is exposed in the mechanical room, in poor condition, with substantial past patching.

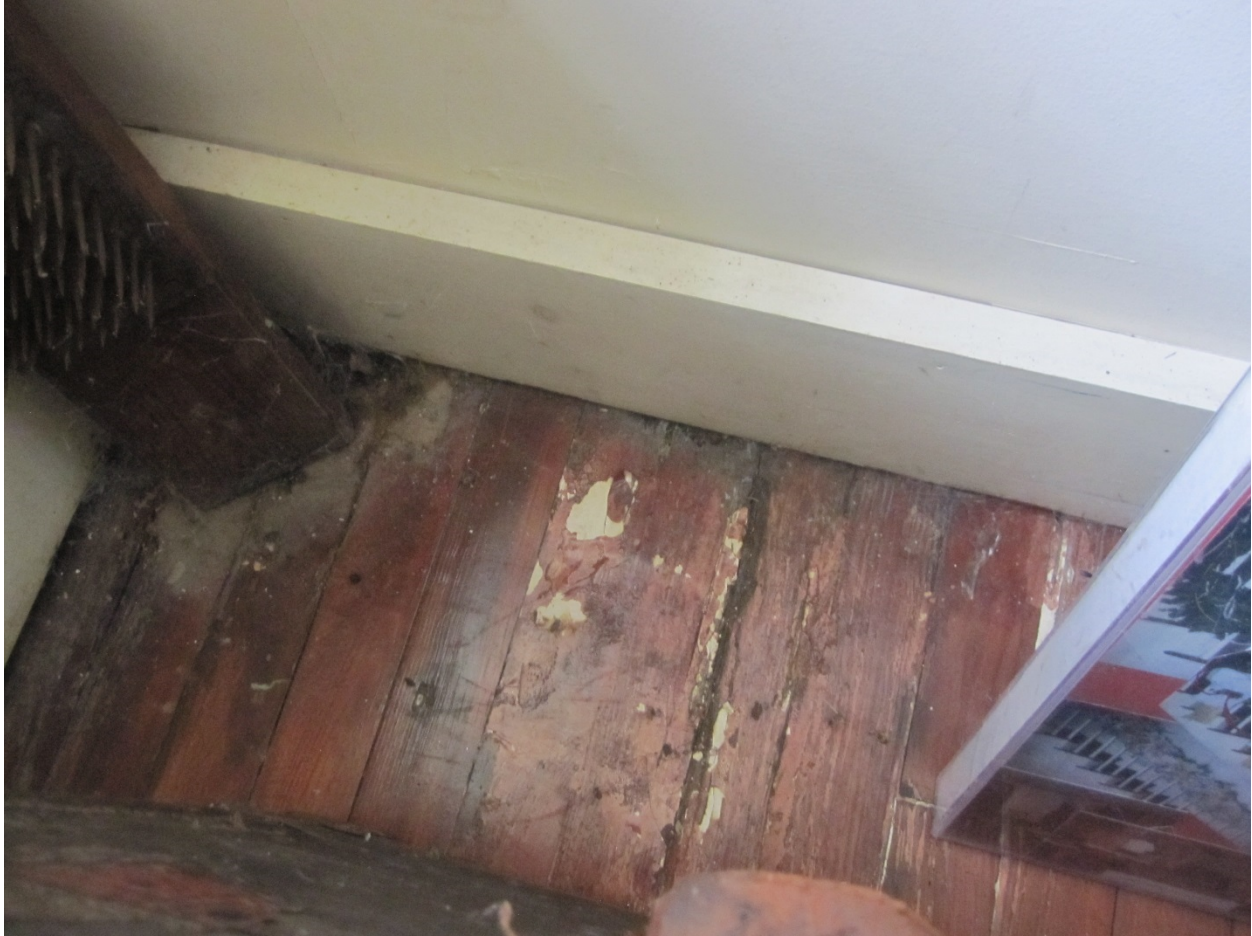
Figure 5. Northeast corner, basement floor.

Floors: Basement floors have a variety of finishes including wood, stone, brick and vinyl, depending on the use of the room. Most are in good condition. Problems are located at the northeast corner of the house, where the wood floor shows signs of warping and rotting (Figure 5).

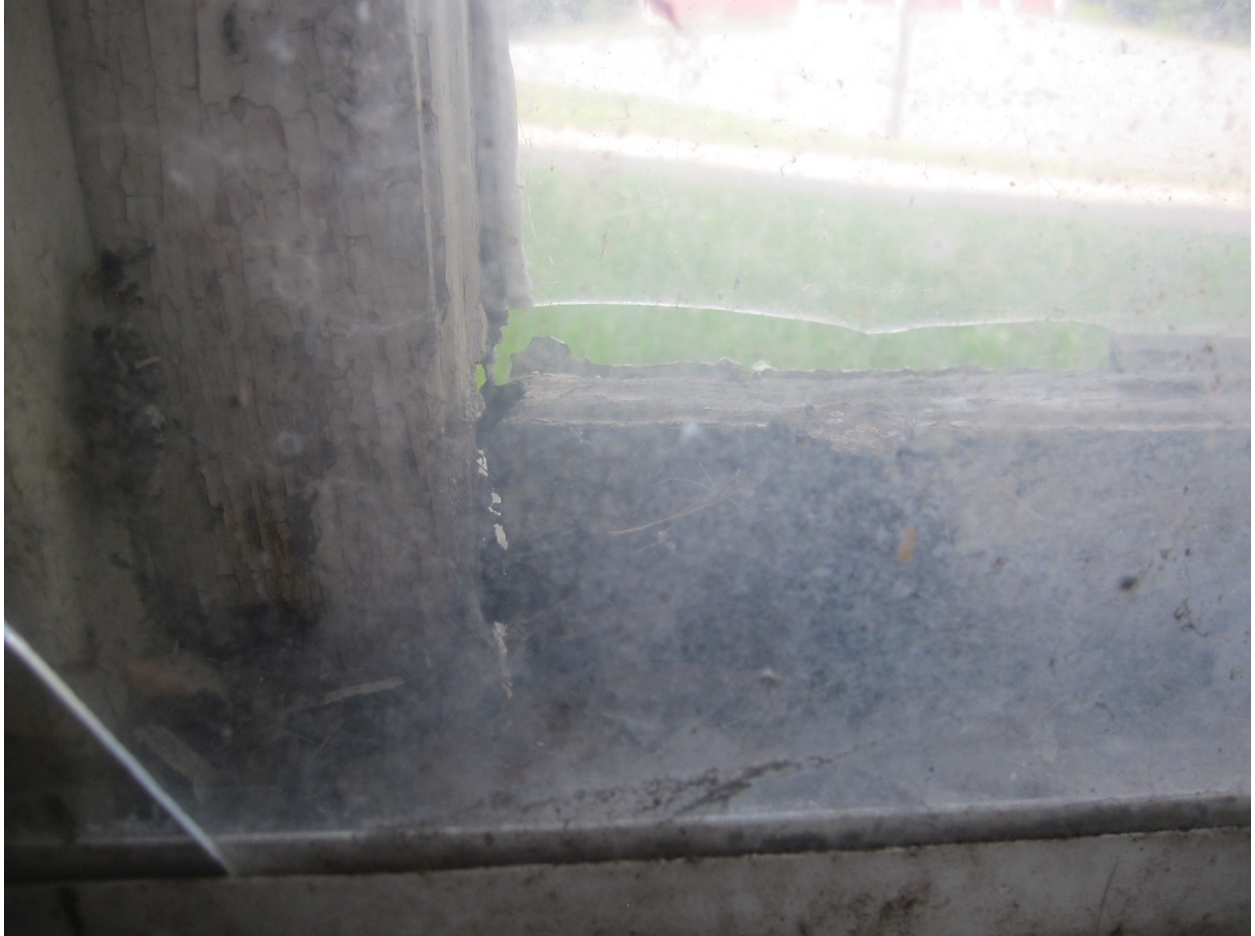
Windows: Just above the location of the rotted floor, a window pane is broken which is unfortunate as it is located at the wettest part of the building, allowing moisture to reside in the sill (Figure 6). Generally speaking, basement windows do not receive the same degree of protection as their upstairs counterparts due to a lack of exterior storm windows and flat exterior stone sills which do not shed water. Interior storm windows prevent dripping into the room, but water still gets down behind the wall as evidenced by the crazing in the wall finish below it (Figure 3). Other basement windows have interior wood window sills, and they too show signs of past water infiltration (Figure 7). Historic photographs show that exterior storms used to protect these windows (Appendix C, Photograph 4).

Figure 6. Window at northeast corner of basement.
Not only is the pane broken, but there is separation of the stile and rail, and rot.

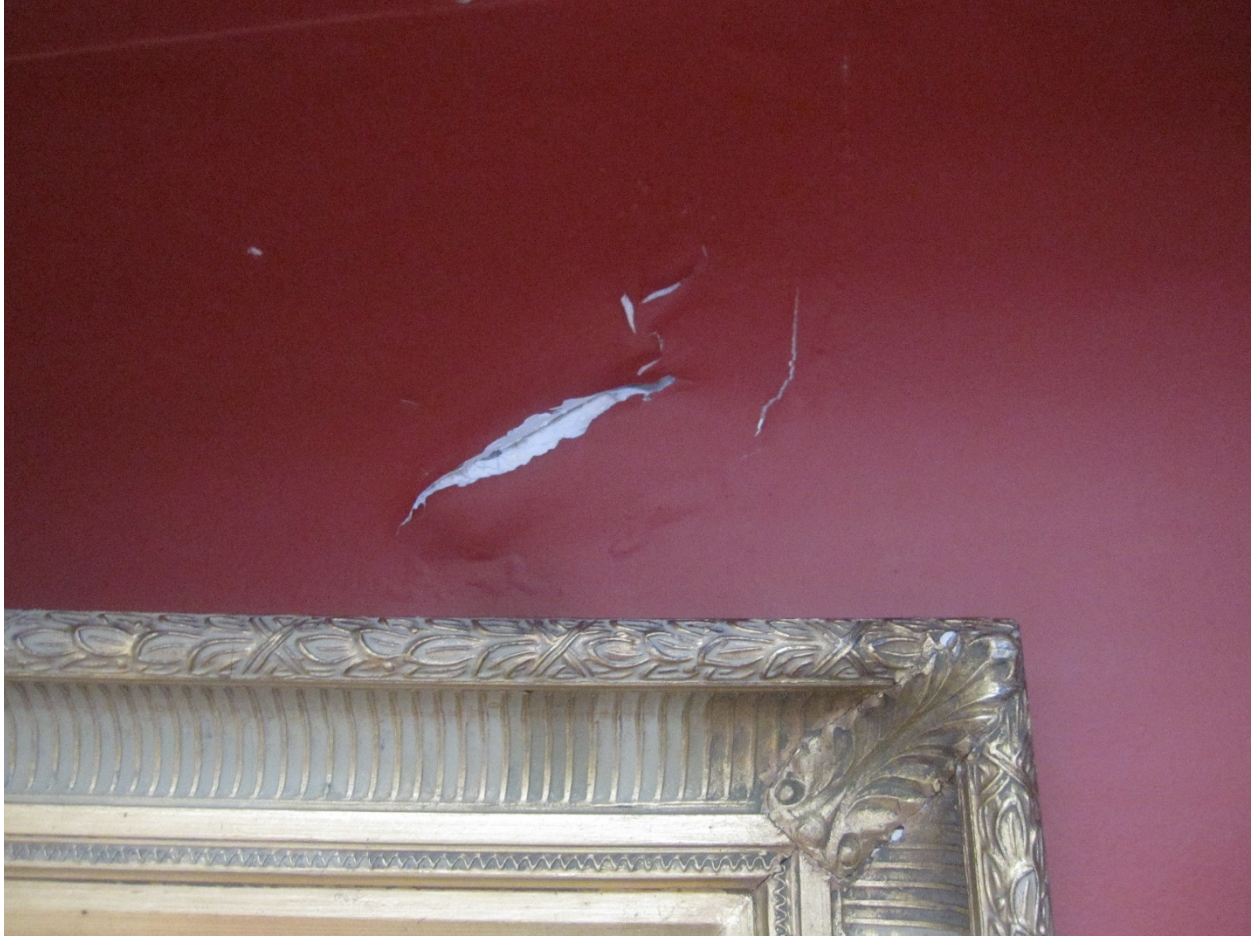
Figure 8. North wall of Dining Room.

Walls: During the 1984 renovation, throughout the first and second stories, the historic plaster was removed, and new plaster and or gypsum board was installed over wall studs (Appendix C, Photograph 8). Any new interior plaster was painted or wallpapered, and has been in place since (Appendix C, Photograph 13). Overall, the first floor walls and their finishes are in good condition. There are discrete locations where water has entered the wall from the exterior. One example is in the dining room (again, at the problematic northeast corner of the house) along the north elevation (Figure 8).

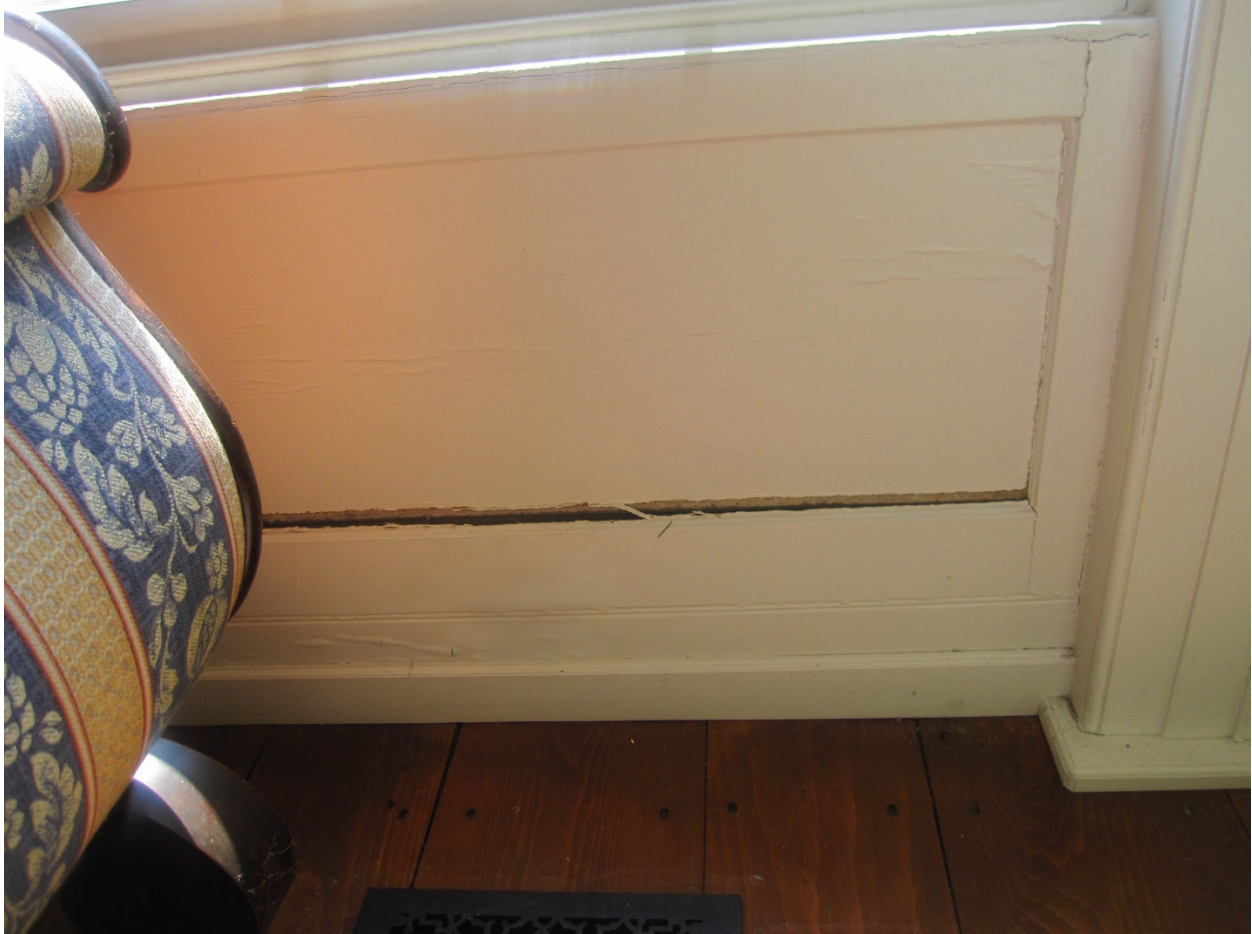
Figure 9. Wood panel below window, typical condition.

Water problems in the wall below the windows have plagued the Pruyn House, as early as 1983. The image in Appendix C, Photograph 8 shows evidence of water entering the brick beneath the windows. This brick butts up directly against the interior wood panels which would explain their cracking and crazing throughout the house (Figure 9).

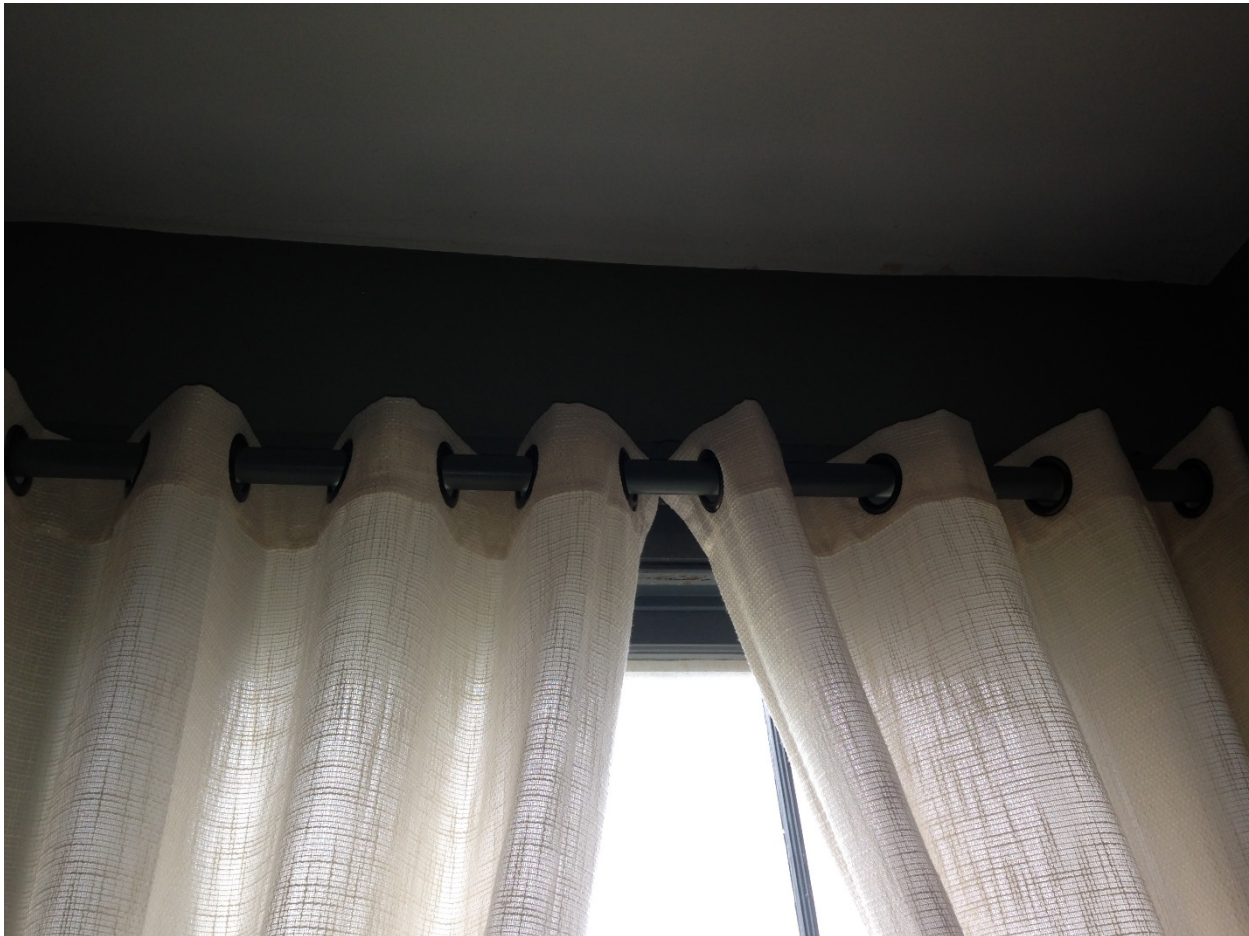
Figure 10. Wall above north elevation window.

In the office located at the center of the north elevation, active water problems within the wall have persisted at and above the window. The amount of wall clearance above the window is less than one foot on the interior, but the small amount of wall is assumed to be saturated based on the condition of the exterior masonry (Figures 1 and 10 and Appendix B, Photograph 14).

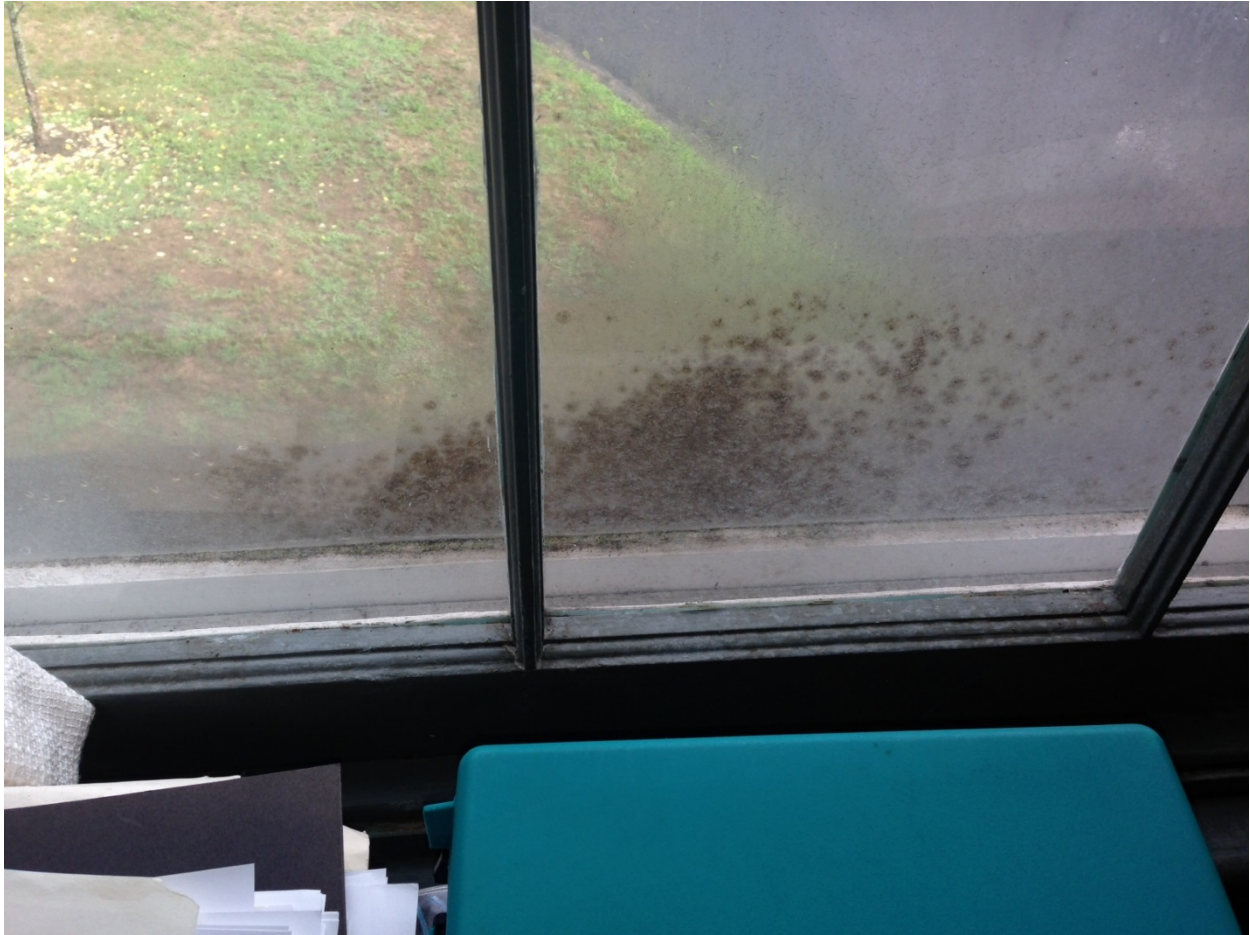
Figure 11. Lower sash of north office window.

the exterior storms, and are in good condition. The one exception is the window at the north elevation, where water is seeping from the head of the window (Figure 11). Recently, the exterior head has been caulked which has provided a temporary solution (Figure 1).

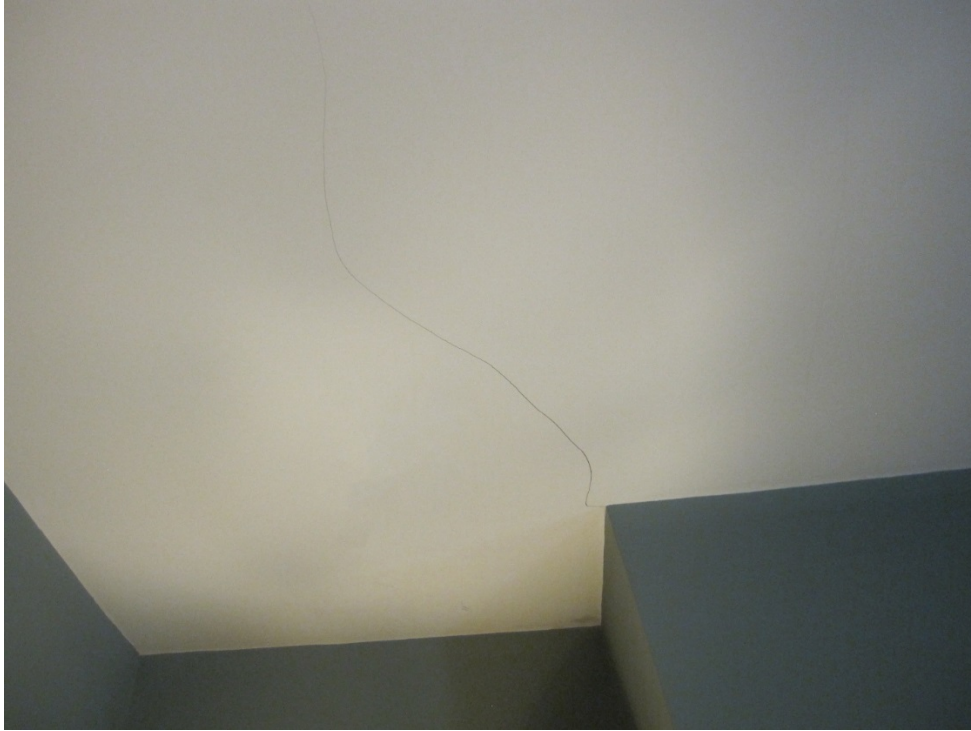
Ceilings: The second floor ceiling slopes to the east, following the slope of the roofline. Past water problems, evidenced by stains, were solved by the installation of a new roof in 2007. However, sitting water on the roof, adjacent to the gutter has resulted in the formation of two new ceiling cracks in the northeast and southeast rooms (Figures 12 and 13).

Figure 12. Ceiling Crack in northeast room.
There is no associated water damage.

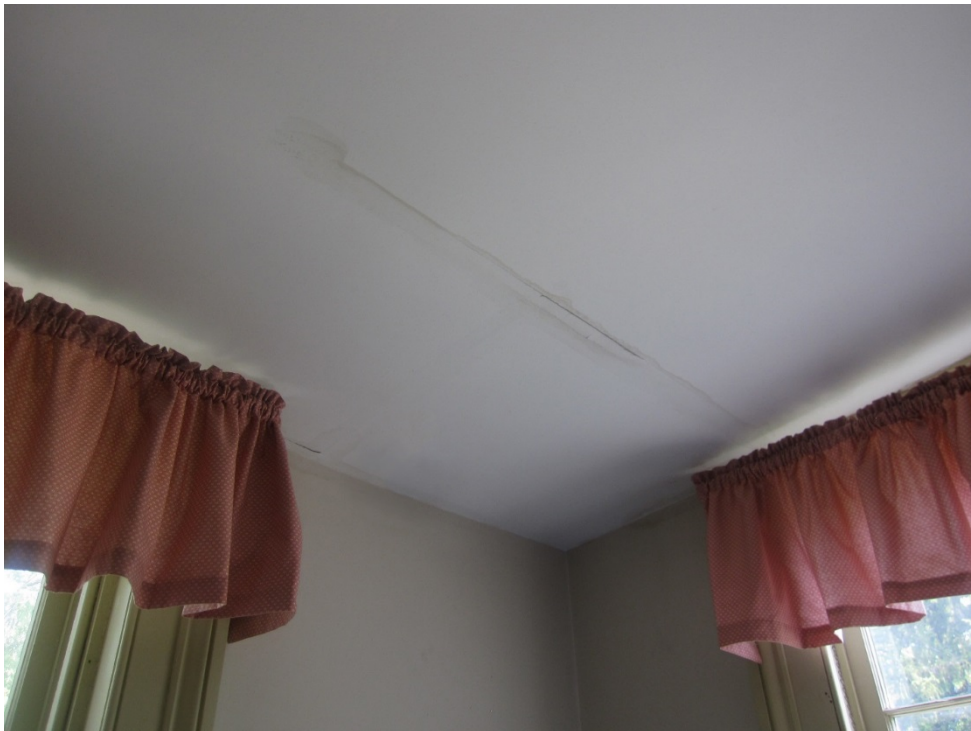
Figure 13. Ceiling Crack in southeast room.
This crack has associated water damage as indicated by the staining.

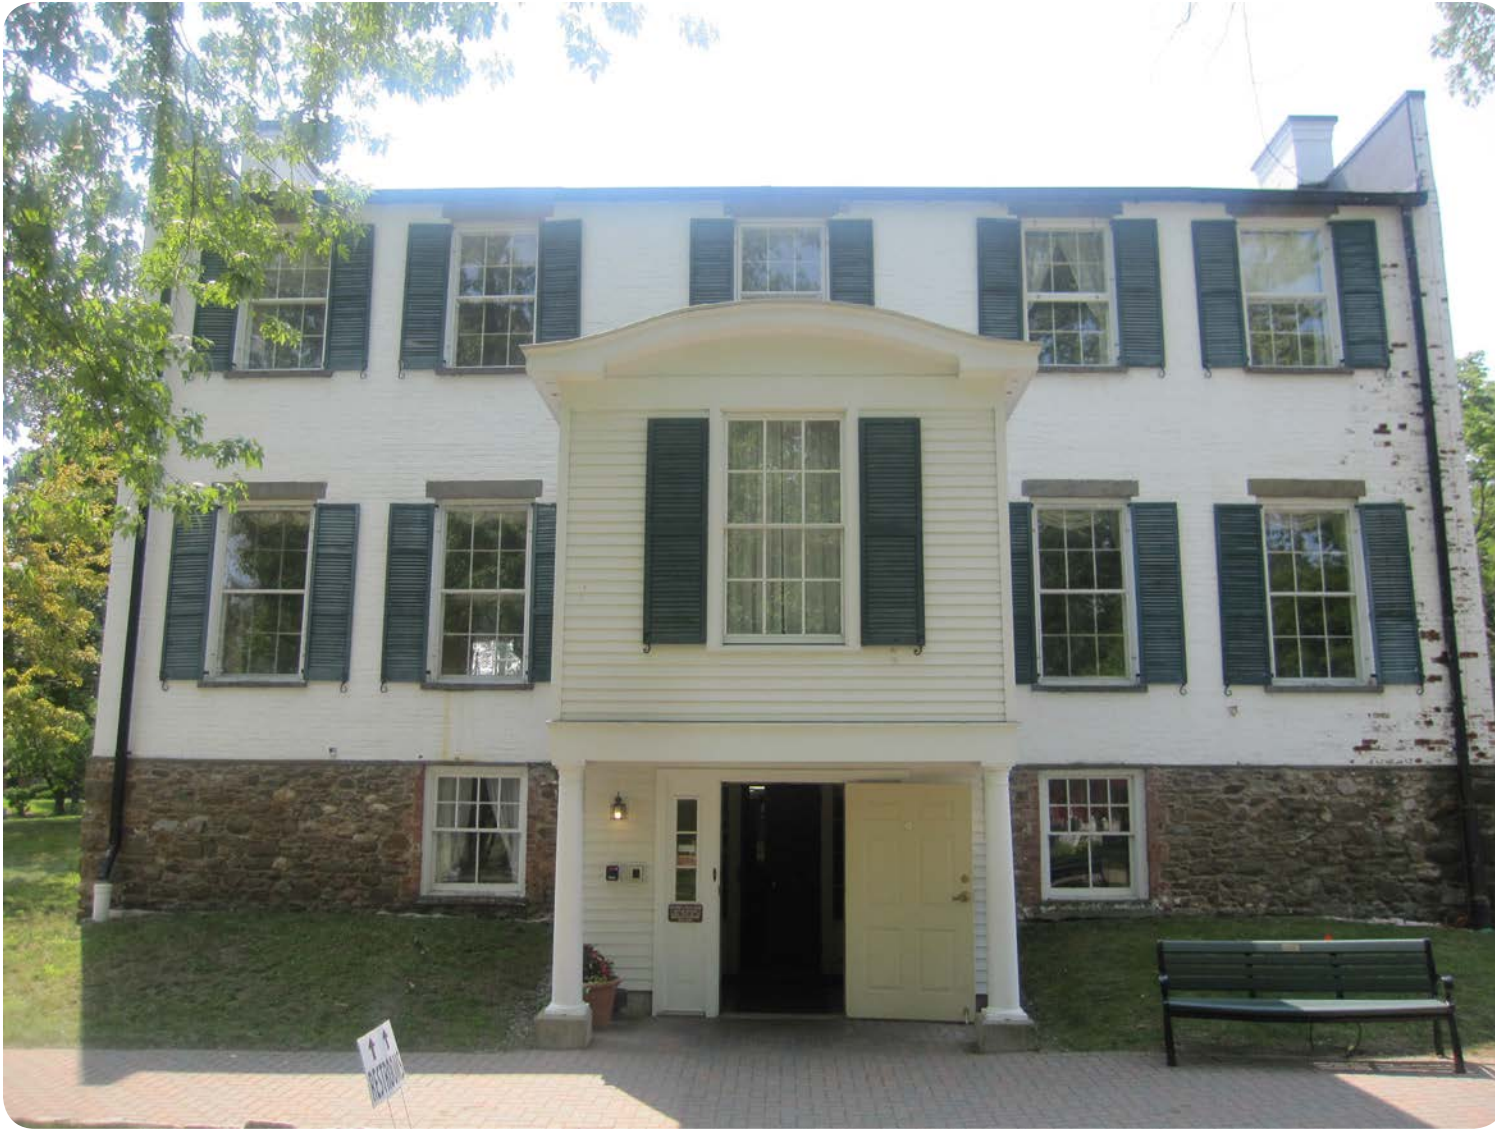
Photo 4

The southern downspout has limited functionality due to the slope of the gutter towards the north (Appendix B, Photograph 4). It removes water at a rate of roughly one drop per second. 2009 testing of the drainpipe below the southern downspout revealed that it is broken or clogged, and as a result, the water overflows out of the boot and sits adjacent to the building.

Unfortunately, history has repeated itself and water problems have recurred at this elevation, this time due to inappropriate brick and mortar replacement in combination with an overflowing gutter (Appendix B, Photographs 4, 14, 15). The brick deterioration is focused at the location of the northern downspout where there is spalling

and loss of brick, as well as behind the entire lengths of the downspout and gutter, where there is also substantial mortar loss. Though minimal, there is some biological growth on the brick behind the northern downspout. Otherwise, the brick of the rear elevation is in good condition, save one stain that extends down from a first floor sill, presumably originating from a rusted anchor (Appendix B, Photograph 4).

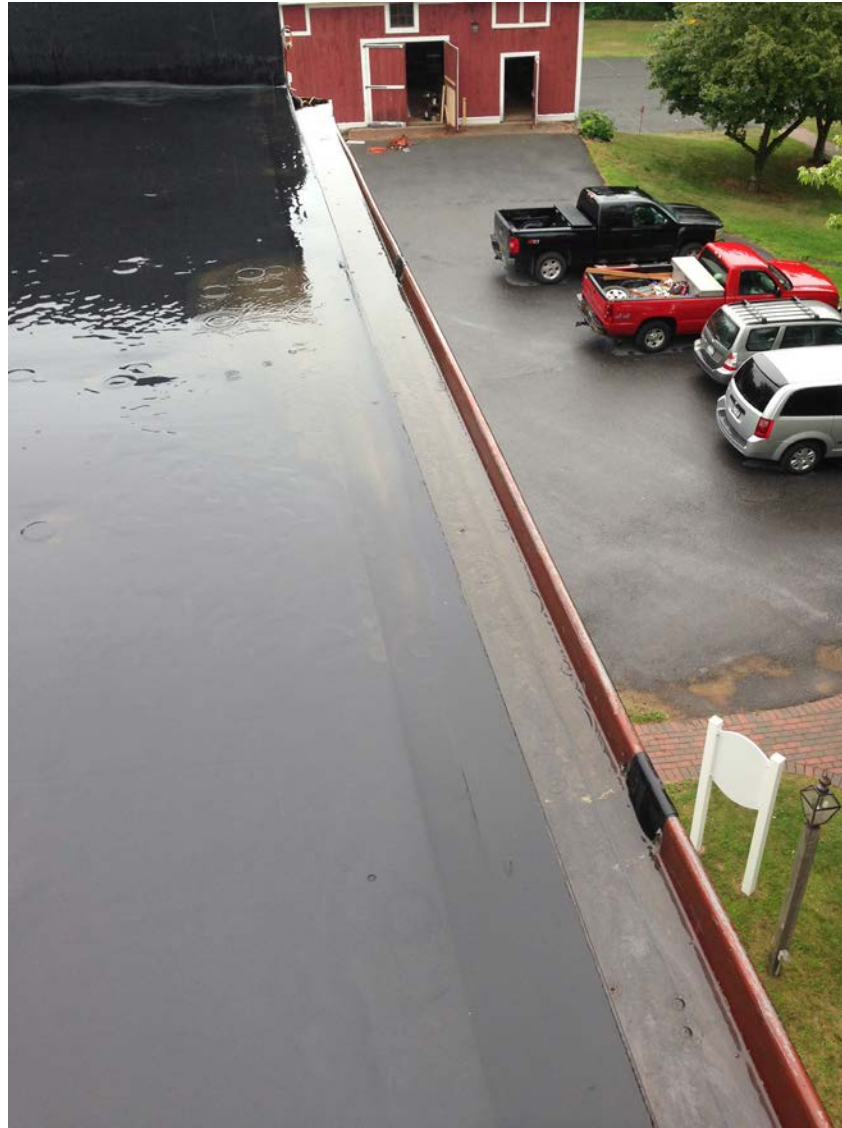
Photo 16

Gutters, Downspouts and Drainage: Because the gutter is sloped to the north, the water naturally moves in that direction. The gutter/downspout connection at the north was clogged with debris, backing up the water halfway across its length, and overflowing onto the roof. During a snowstorm, this situation is reported to cause ice damming, which may also involve the lifting of the roof system if ice expands underneath the sheathing (Appendix B, Photograph 16).
