Cultural Landscape Report

Chittenango Landing Dry Dock Complex

Town of Sullivan, Madison County, New York

November 2014

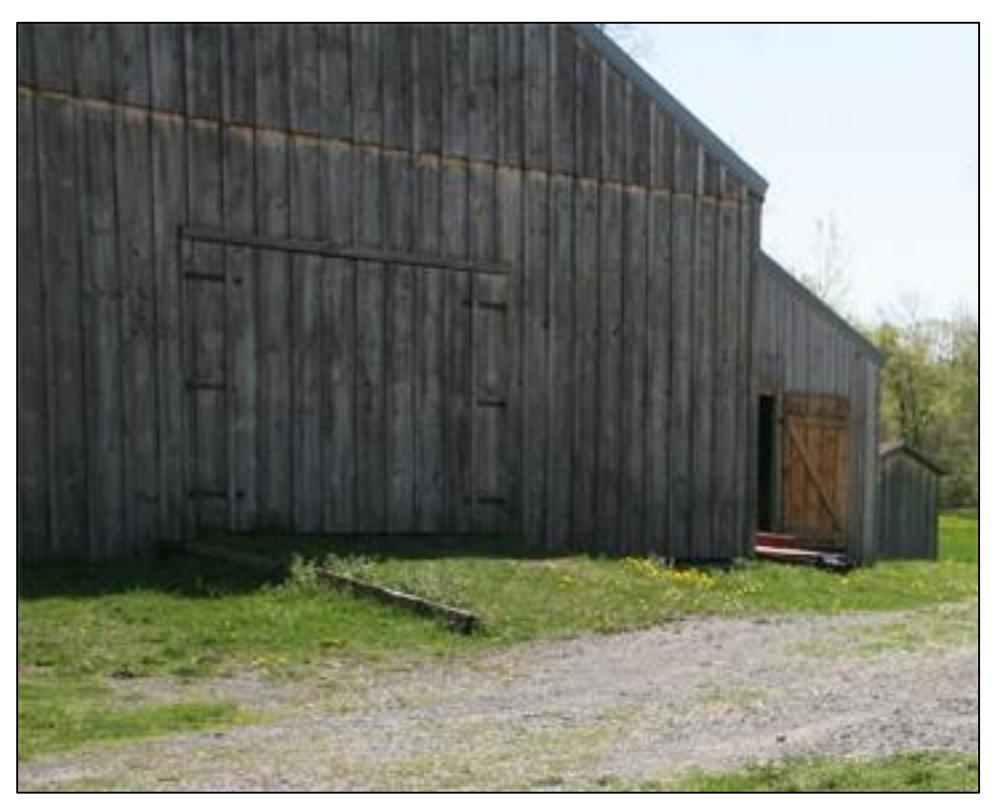
Figure 3.20. Dirt and grass ramp with poor accessibility, Blacksmith and Sawmill Complex (Photo by EDR, 2013)

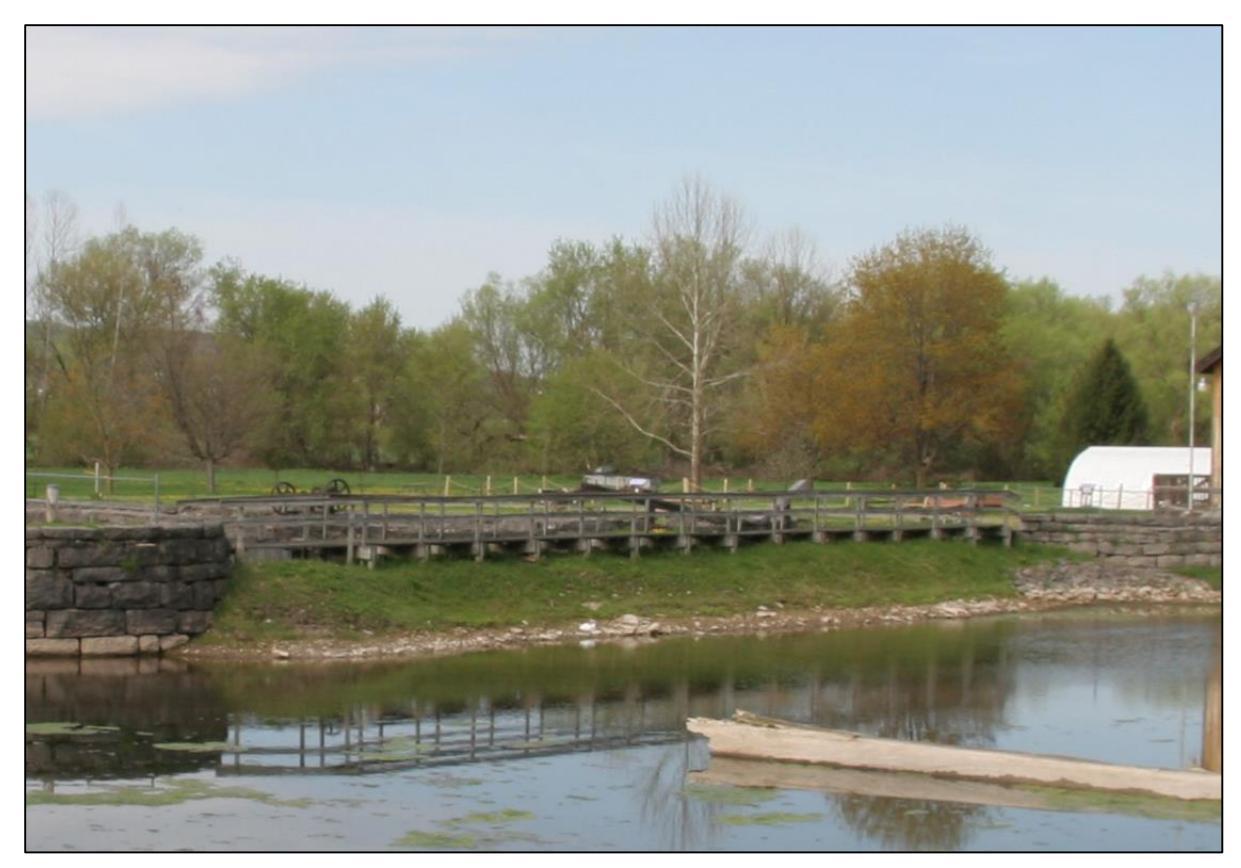
Figure 3.47. Earthen dam separating the dry dock complex from the Erie Canal. (Photo by EDR, 2013)

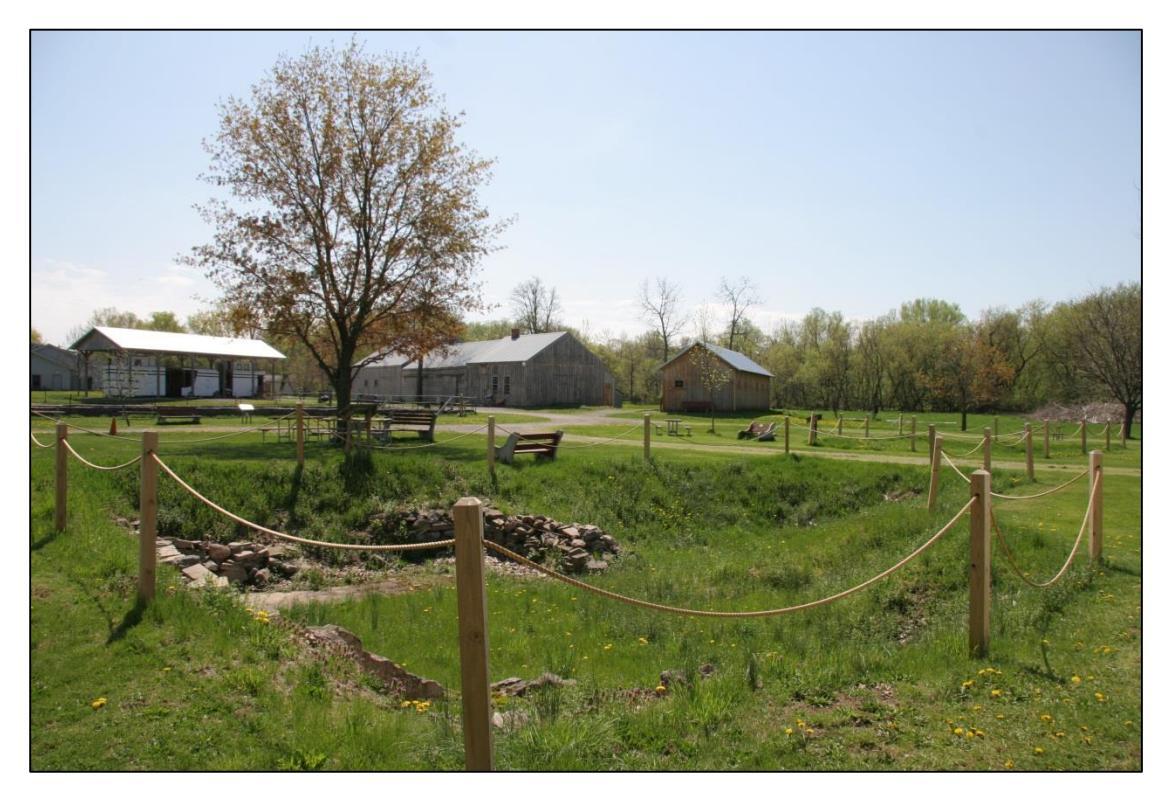
Figure 3.67. Main House foundation. (Photo by EDR, 2013)

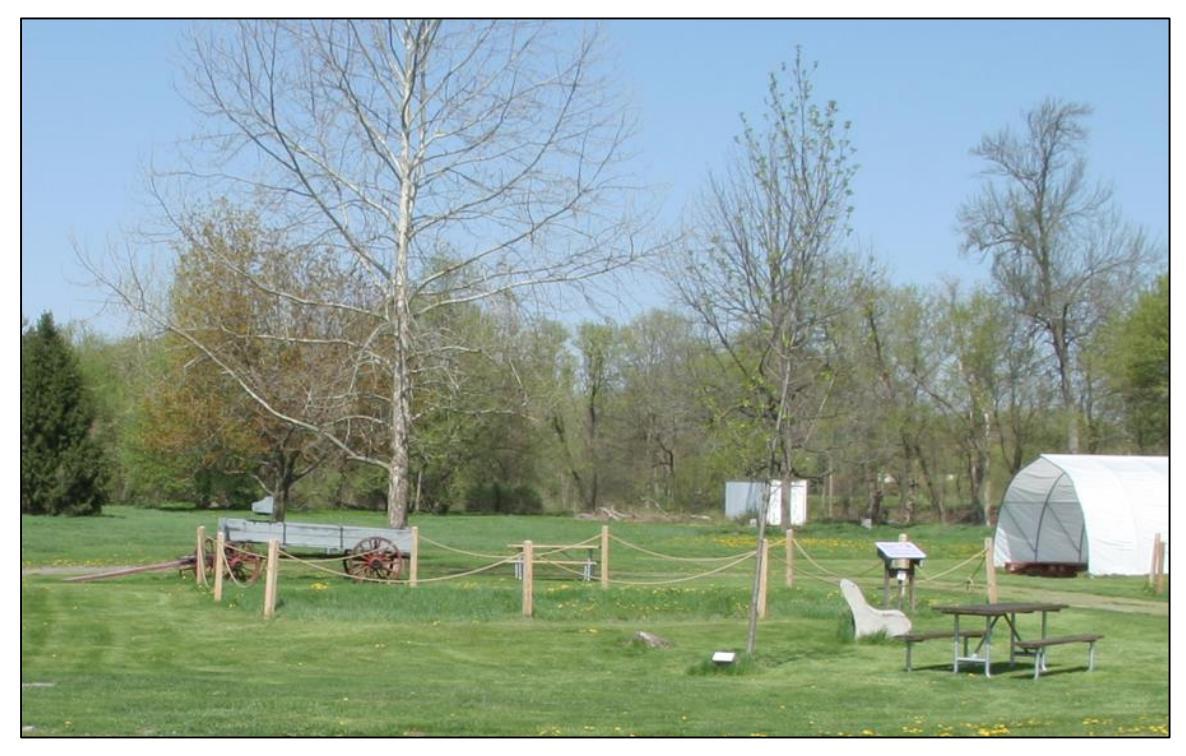
Figure 3.68. Tenant House foundation. (Photo by EDR, 2013)

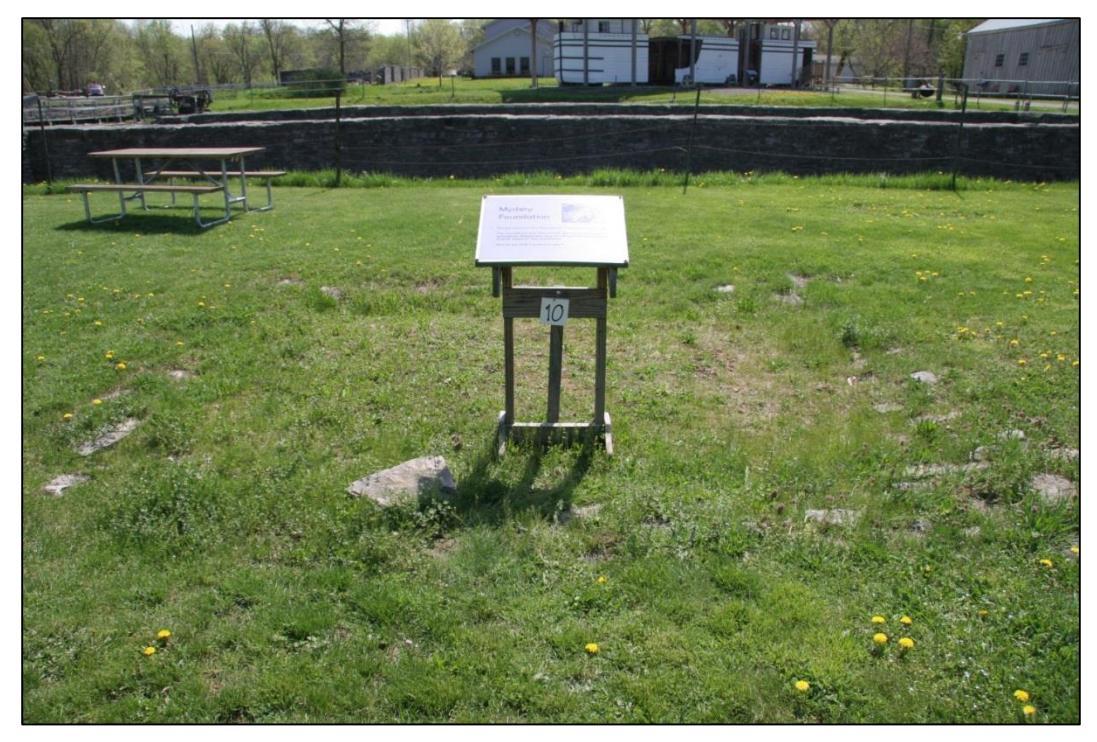
Figure 3.69. The "Mystery" foundation. (Photo by EDR, 2013)

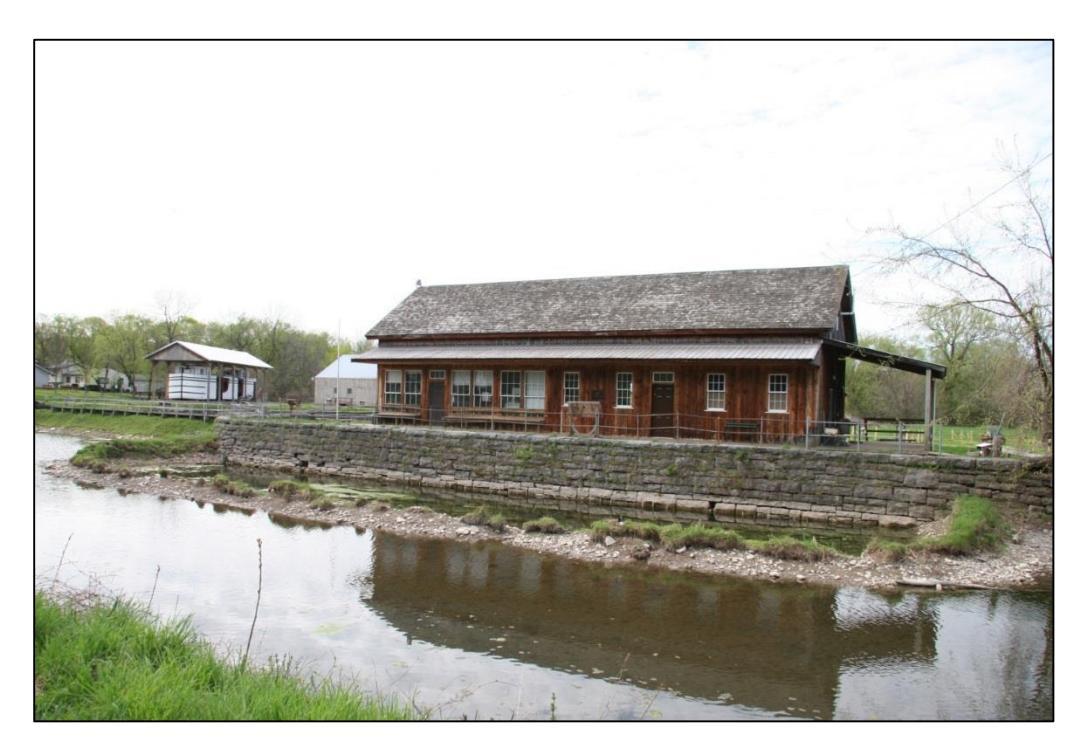
Figure 3.72. Sunken canal boat site - north of the Store and Warehouse building. (Photo by EDR, 2013)
