# A Visual Field Guide

# Village of Danforth Historic Resource Survey

## Syracuse, New York

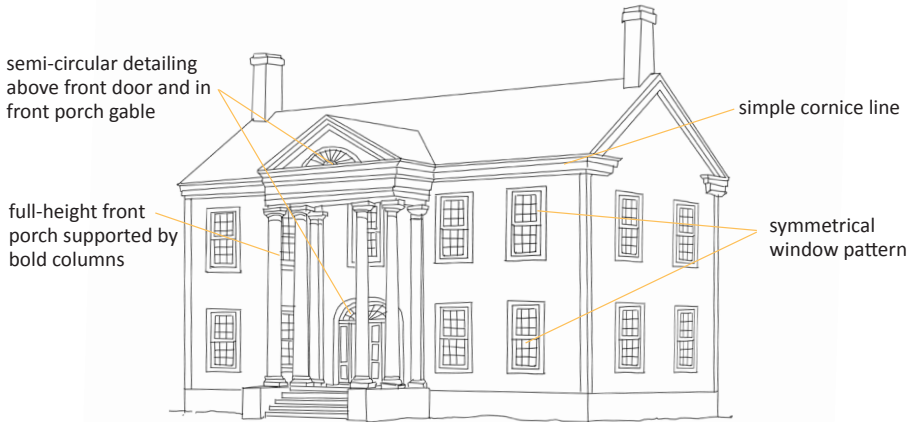
## 9] Architectural Style: **CLASSICAL REVIVAL**

- Entry porch dominating front façade
- Symmetrical windows ranked with five, three or seven
- Porch supported by full-height columns
- Shallow, square base pillar supports
- Columns support prominent front gable, usually centered

- Often semi-circular or elliptical window found above front door
- Semi-circular or elliptical window or decorative element may also be present in the front porch pediment
- Entry porch typically full height of home
- Window layout typically vertically and horizontally symmetrical with five spaced across façade, three and seven-ranked also seen
- Usually lacks wide band of decorative trim at cornice line

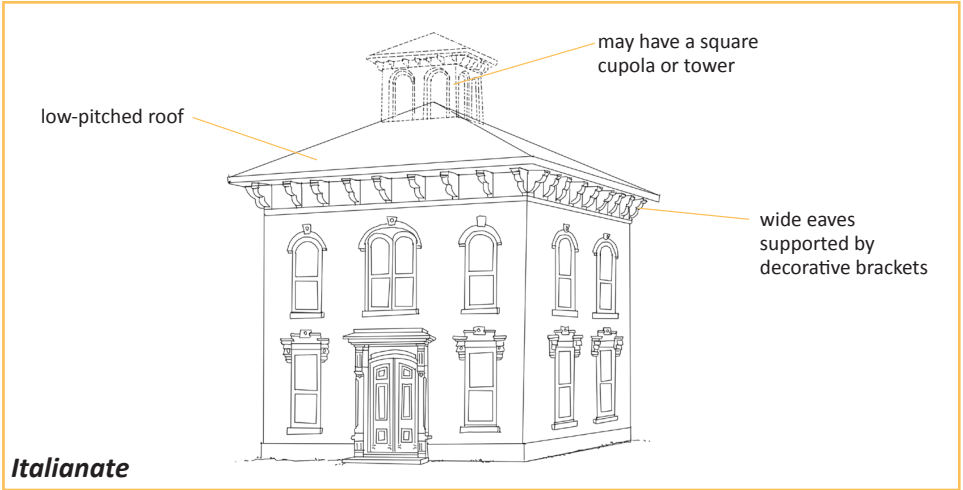
9] Architectural Style: **ITALIANATE**

- Two to three stories
- Low-pitched roof
- Wide, overhanging eaves
- Decorative brackets
- Tall, narrow windows, commonly arched or curved above
- Many have a square cupola or tower

- Simple hipped or front-gable roof
- Windows have one or two panes
- Large cornices with eave brackets frequently elaborate as well as simple
- Porches almost always present are single storied and relatively refrained in ornamentation
- Small front porches are most common
- Square post porch supports with beveled corners are most frequent
- Doors surrounds are similar to ornamentation over windows

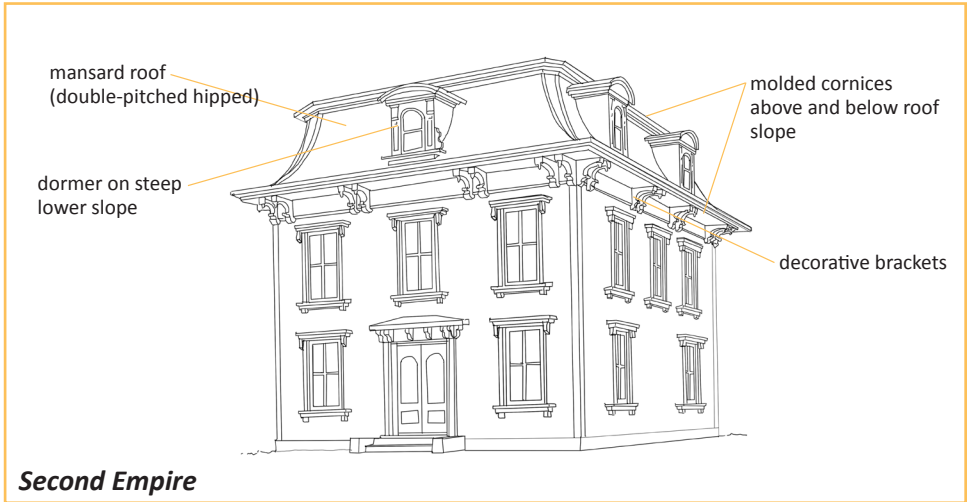
## 9] Architectural Style: **SECOND EMPIRE**

- Distinctive mansard roof
- Eaves with decorative brackets
- Molded cornices above and below roof slope
- Dormers in steep, sloping roof
- Square or rectangular layout

- Decorative patterns of color and texture in roofing material
- Square or rectangular tower
- Style commonly adapted for townhouses or commercial structures
- Similar in style to Italianate houses below the roof line
- Iron cresting may be present above upper cornice
- One or two-story bay windows

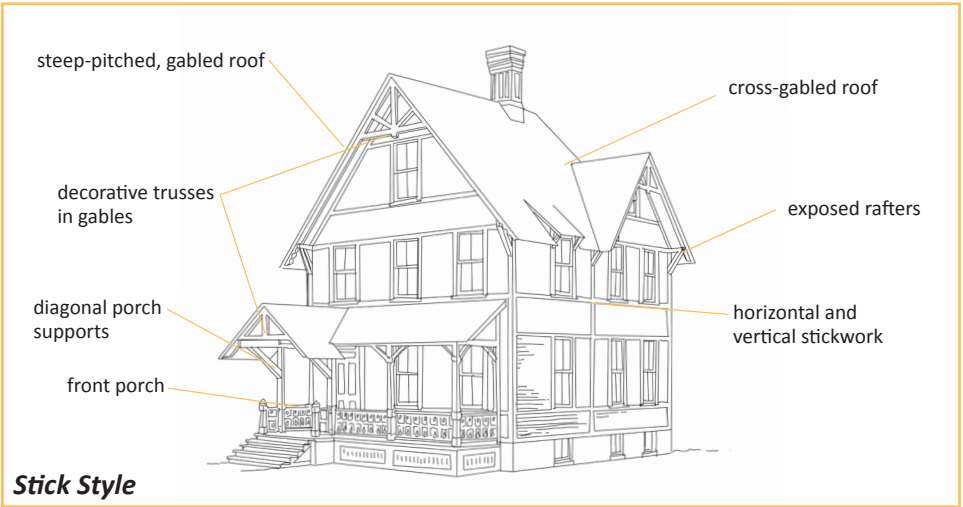
g] Architectural Style: **STICK STYLE**

- Patterns of horizontal, vertical and/or diagonal boards (stickwork) raised above wall surface
- Decorative trusses in gables
- Porches have diagonal or curved supports
- Steep-pitched roof

- Exposed rafter ends
- Wall cladding usually wood or wood shingles
- Cross-gabled roof common
- Square or rectangular tower may be present
- Entry or full-width porch
- Townhouse versions common with flat roofs

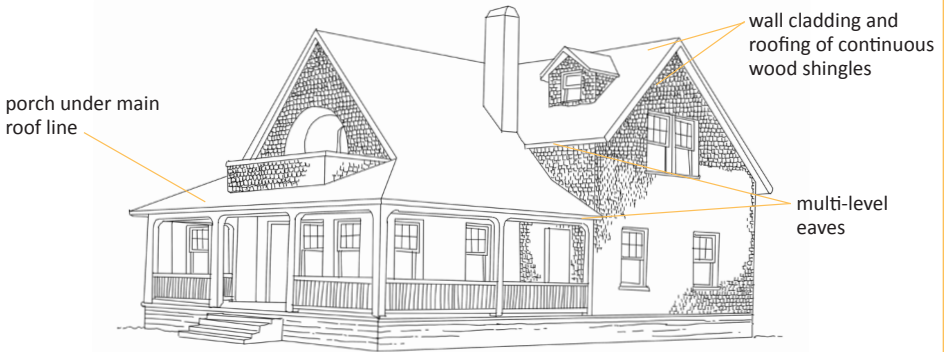
## 9] Architectural Style: SHINGLE STYLE

- Wall cladding and roofing of continuous wood shingles
- Asymmetrical façade and body
- High-pitched roof
- Shingles wrap around corners
- Techniques used to make home look like one continuous shape

- Irregular roof line may be gambrel, gabled, hipped, or a combination of the three
- Shingles may occur on second story only
- First story may be stone
- Towers blended into main volume of home
- Original wood shingle roof commonly replaced by asphalt shingles
- Porch roof often incorporated into main volume of home
- Urban porch may be small or non-existent
- Country porch usually extensive
- Dormers common

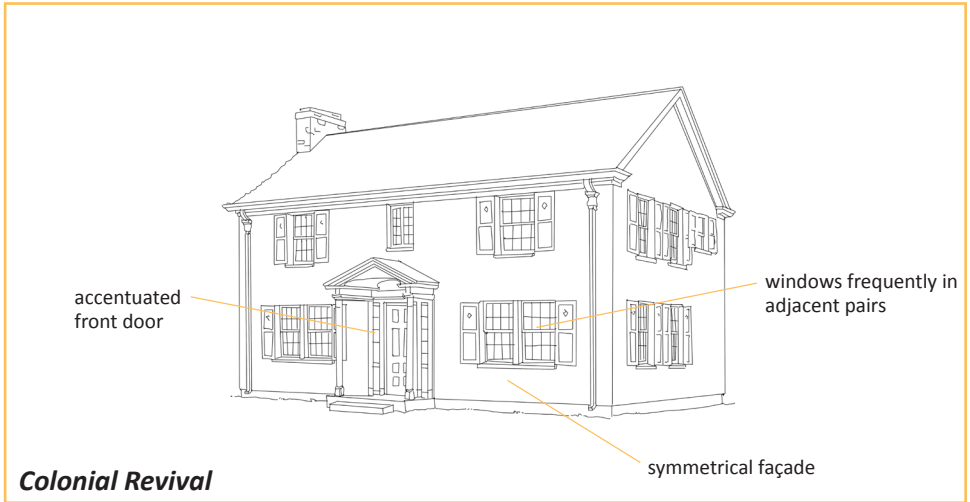
## 9] Architectural Style: COLONIAL REVIVAL

- One to three stories
- Accentuated front door
- Door commonly emphasized with a decorative crown supported by pilasters or with columns and a small front entry porch
- Symmetrically balanced façade with windows and center door
- Windows with multi-pane glazing
- May have side-gabled, hipped or gambrel roof

- Door may have overhead decorative window or decorative side accent windows
- Asymmetrical façade does appear, commonly with an attached garage
- Full-width porch may be present
- Dormers common
- May find front-gabled roof on narrow lot
- Masonry, stone veneer or wood wall cladding most common

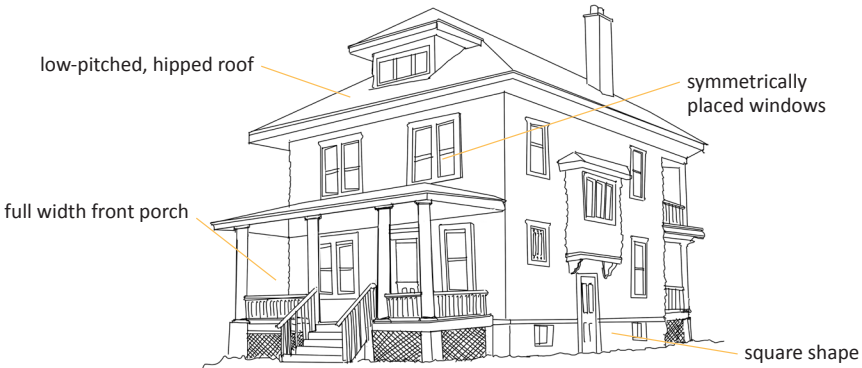
## g] Architectural Style: **FOUR SQUARE**

- Two to three stories
- Low-pitched hipped roof
- Large, simple windows
- Front porch almost always present
- Dormers common
- Box or cube shape
- Wide, overhanging eaves
- Symmetrical appearance

- Porch column shapes vary with preference
- Four small roof dormers or one dominant front dormer are common
- Windows usually double hung
- If window detailing, usually multi-pane upper sash and single-pane lower sash
- Bay window in dining or living room
- Wide front porch stairs
- Exterior wall texture may differ from first to second floor
- Commonly accompanied by a matching, detached garage
- Front door detail bold and simple
- Bold roof brackets

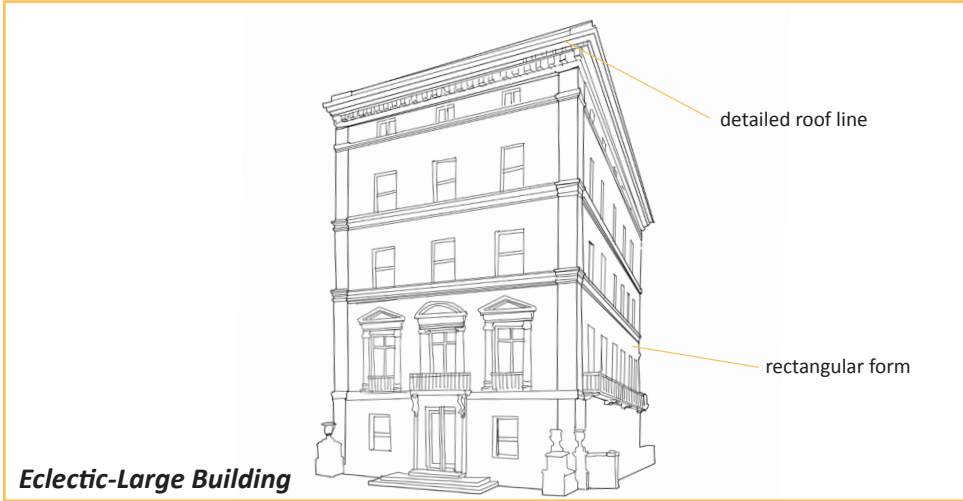
g] Architectural Style: **ECLECTIC- LARGE BUILDING**

- Two or more stories
- Multiple entrances
- Combines multiple architectural style elements
- Types of buildings include churches, apartment buildings, commercial buildings, libraries, etc.

- Rectangular or symmetrical form
- Greatest stylistic detail usually seen in roof lines and entrances
- Most often built of brick or stone
- Various window types may be present
