Cultural Landscape Report

Chittenango Landing Dry Dock Complex

Town of Sullivan, Madison County, New York

November 2014

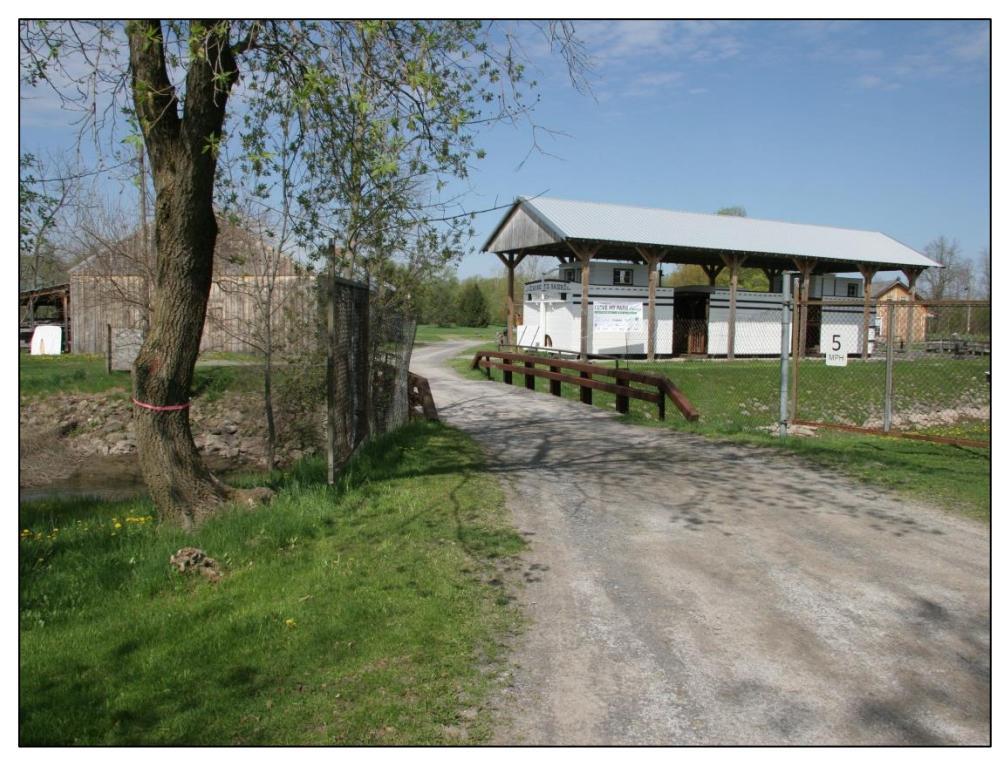
Boatyard – The Boatyard is the active space located south of the Enlarged Erie Canal, west of the Chittenango Canal, and bordered on the west and south by the Open Field. The entrance to the dry dock complex along Boatyard Road over the Chittenango Canal is constricted on the west end of the bridge by the boat model and the sawmill complex (Figures 3.4 and 3.5). The full extent of the Boatyard expands as the angle of these two buildings directs people and views into the space. The Boatyard is generally comprised of open lawn and paved (stone dust or gravel) roadways and pathways. This area is adjacent to the Open Field, however, there is a distinct perimeter to the Boatyard comprised of the Blacksmith/Sawmill Complex (south), mature specimen trees and house foundations (west), the Store and Warehouse building (northwest), the Erie Canal (north), and the boat model (east). The arrangement of these structures provides a sense of enclosure and focused activity to the Boatyard. The dry dock bays, which are large, rectangular, stone-lined excavations, provide a focal point in the center of this space and are bounded by perimeter fencing. Vantage points along the perimeter fence and adjacent lawn areas provide opportunities for views into the bays of the dry docks.

Figure 3.4. Constricted entry on Boatyard Road to the Dry Dock Complex space from the east side of the bridge. (Photo by EDR, 2013)

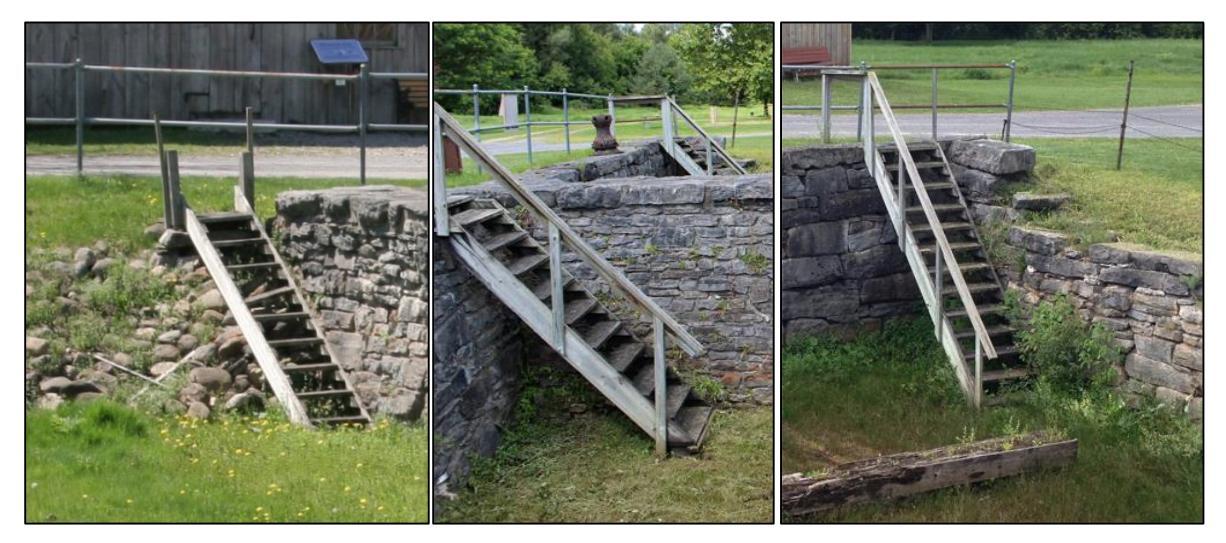
Wood staircases – Wood staircases are present in the southwestern corner of each of the dry dock bays (Figures 3.14-3.16). They are not currently available for public use due to safety issues. The light bay stair measures 2' wide and has nine risers; this stair does not have a railing. The medium bay stair measures 3'-2" wide and has 11 risers with a 34" high railing on the east side. The heavy bay stair measures 2'-11" wide and has 13 risers with a 34" railing on the east side.

Figure 3.14 (left). Wood staircase – southwest corner of light bay. (Photo by EDR, 2013) Figure 3.15 (center). Wood staircase with wood railing – southwest corner of medium bay. (Photo by EDR, 2013) Figure 3.16 (right). Thirteen riser wood staircase with wood railing – southwest corner of heavy bay. (Photo by EDR, 2013)

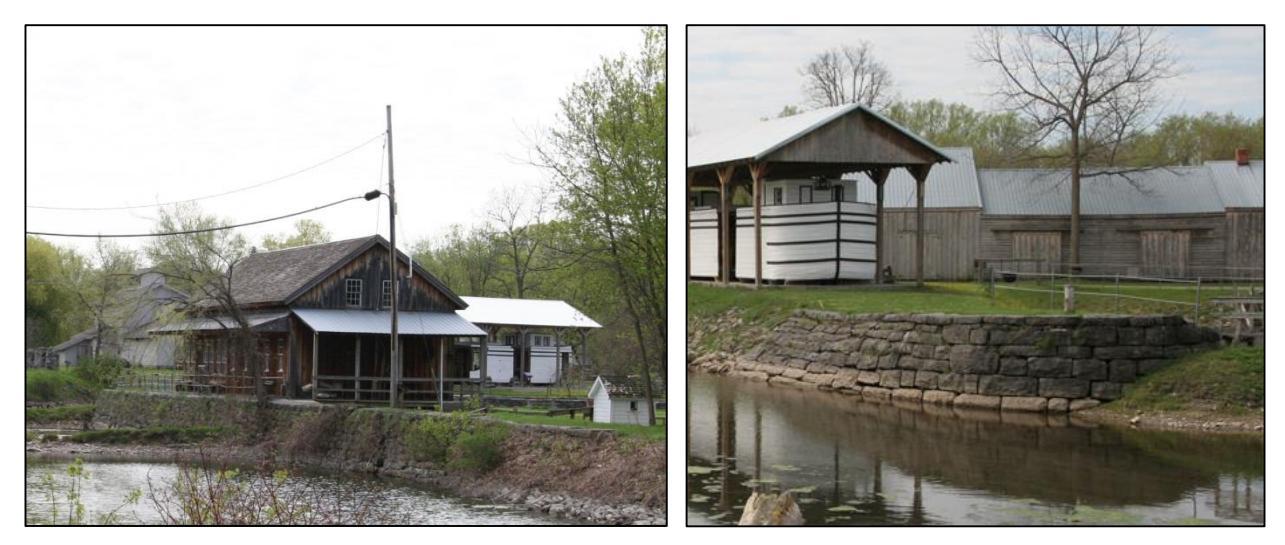
Figure 3.24. (left). Southern wall of the Erie Canal within the western portion of the study area. (Photo by EDR, 2013) Figure 3.25. (right). Southern wall at the confluence of the Erie Canal and the Chittenango Canal. (Photo by EDR, 2013)

The west wall of the Enlarged Erie Canal begins at the earthen dam at the northwest corner of the dry docks, curves to the west and extends along the south edge of the Canal (Figure 3.24). The total length of this wall within the study area measures 250 linear feet. There are additional limestone retaining walls to the east along the southern edge of the Canal. These walls flank the intersection of the Chittenango Canal with the Erie Canal (Figures 3.25 and 3.26). A limestone bullnose wall begins at the northeast corner of the dry docks, curves to the east and extends south along the western edge of the Chittenango Canal. The total length of this wall measures 55 feet. The southern wall of the Erie Canal continues east of the intersection of the two canals, curves east and continues to the east. The northern side of the Erie Canal prism is primarily composed of steep sloping banks with stone riprap (or partially dislodged limestone blocks) overgrown with low herbaceous vegetation (Figure 3.27).

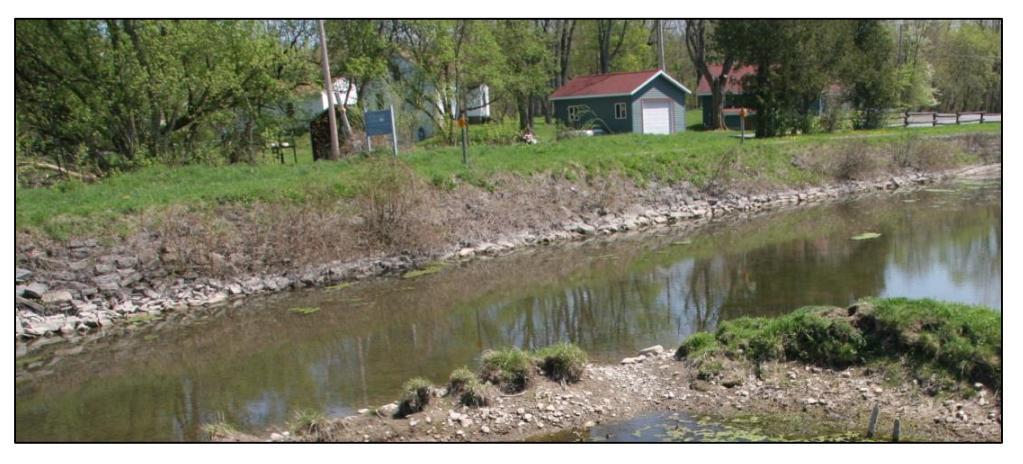
Figure 3.27. Northern wall of the Erie Canal opposite the dry dock complex. (Photo by EDR, 2013)

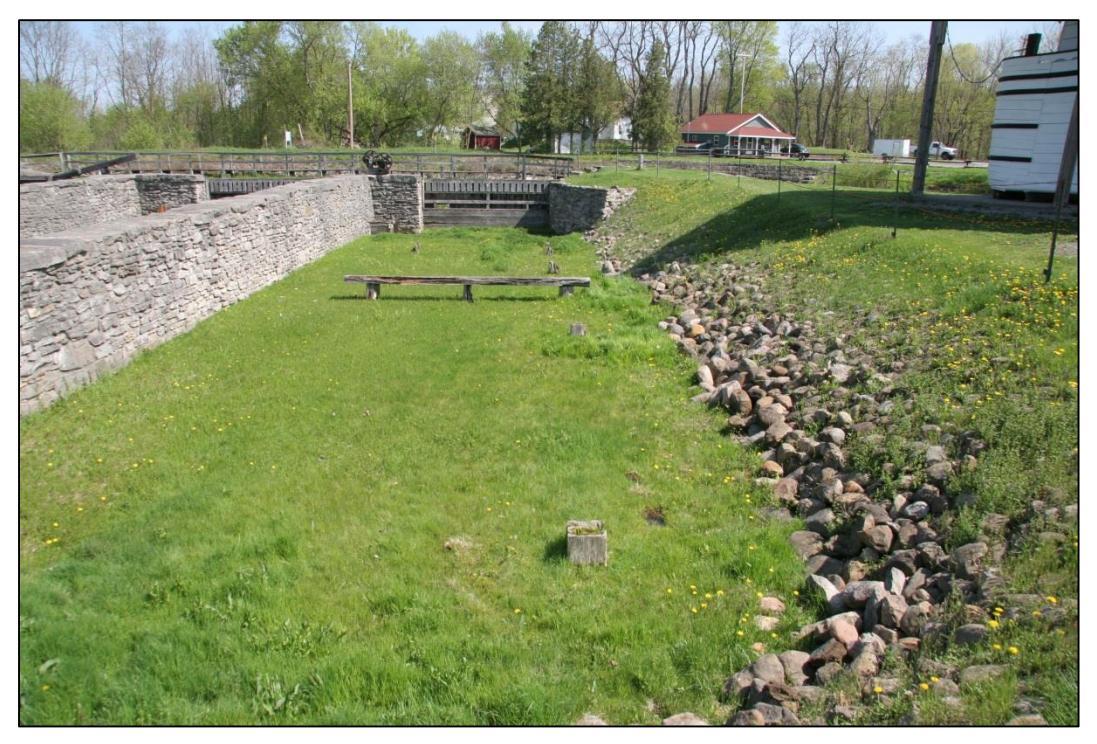
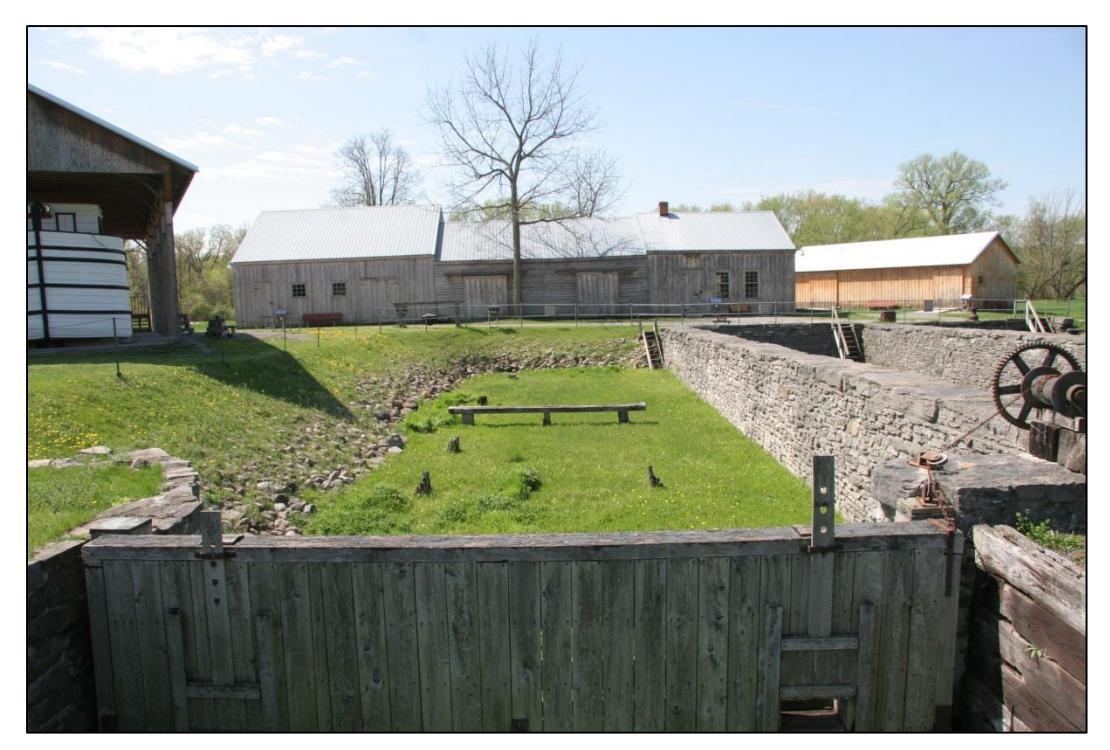
The east (or light) bay (Figures 3.28 and 3.29) has gently sloping southern and eastern side walls (rebuilt in 1995), covered with vegetated melon-sized riprap. The west wall (uncovered in 1986) was rebuilt in 1995 on top of the remaining stones from the original wall. The new stones are irregular pieces of rough cut limestone laid in an ashlar pattern. Thick limestone capstones top the wall. The dimensions of the bay are 26 feet at its widest point, 105 feet at its longest point, with a depth of six feet. The western wall of this bay is a masonry wall constructed of limestone blocks, measuring five and a half feet wide at the base and four feet wide at the top. The floor of the bay is covered by grass and other low, volunteer vegetation. Eight vertical wood timbers on the ground surface (or partially buried) are visible in the grass running in a straight line north/south along the eastern edge of the bay. All existing wood elements above the ground are non-original and display significant deterioration.

Figure 3.28. Light bay of the dry dock - view north. (Photo by EDR, 2013)

Figure 3.29. Light bay of the dry dock – view south. (Photo by EDR, 2013)

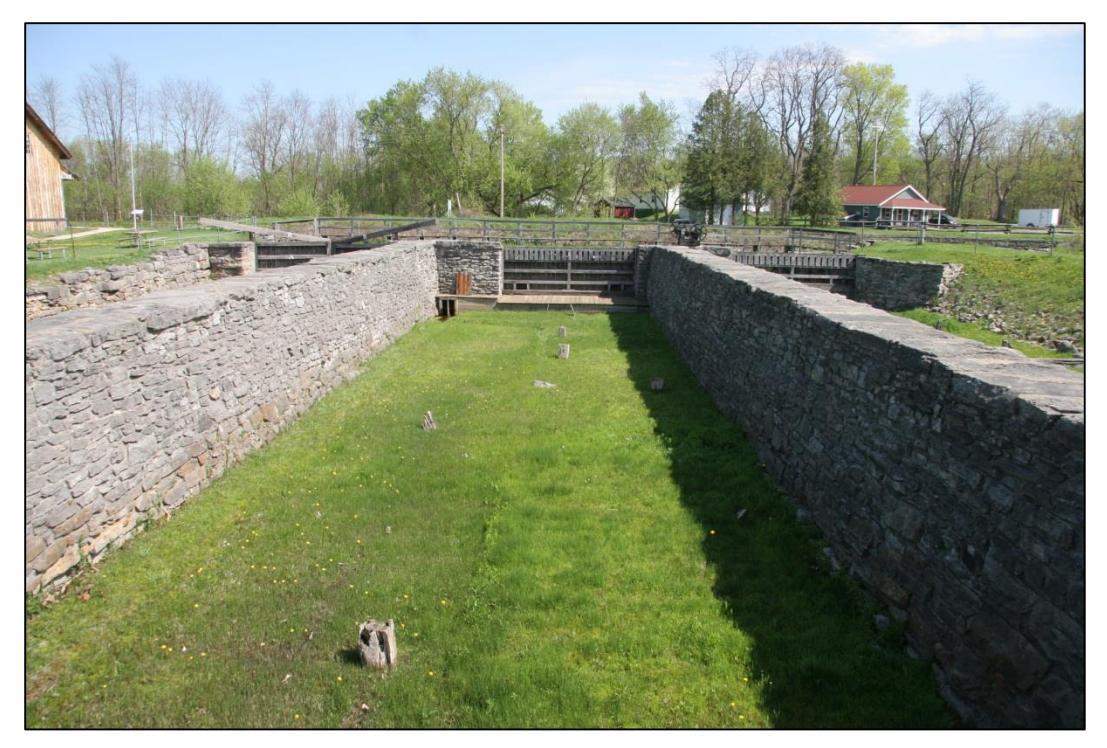
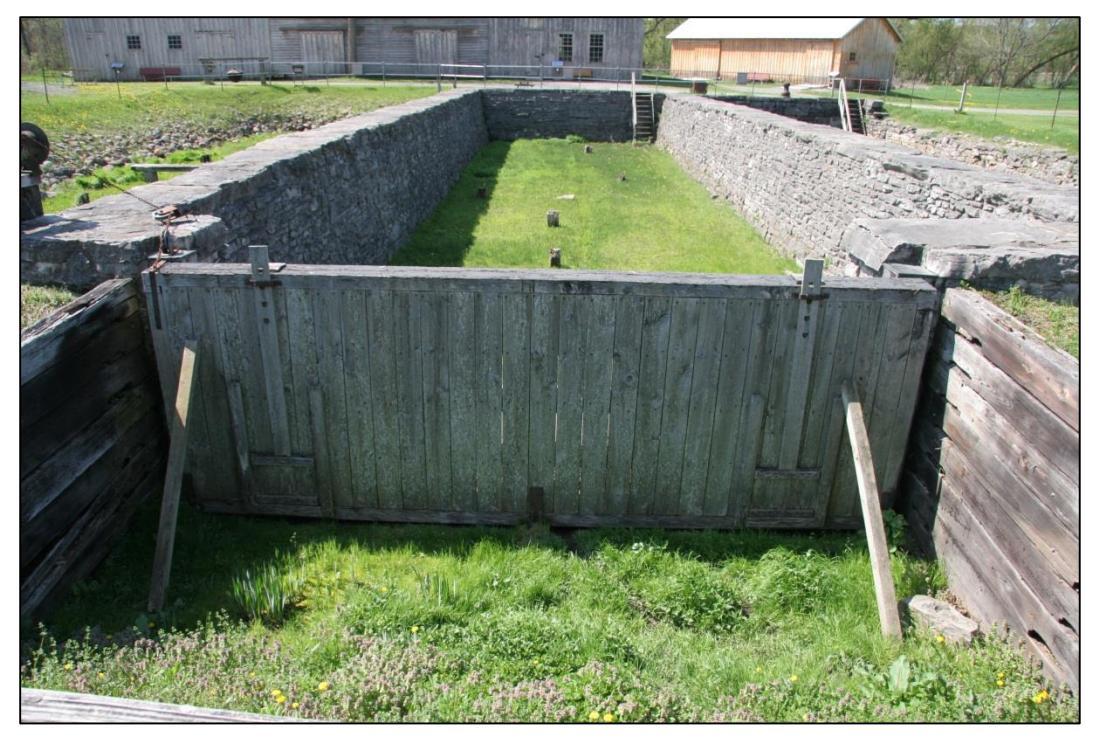
Figure 3.30. Middle bay of the dry dock - view south. (Photo by EDR, 2013)

The middle, or hundred-ton bay (Figures 3.30 and 3.31), measures 26 feet wide at its base105 feet at its maximum length, and seven feet deep. The south, east, and west walls of the bay are constructed of limestone and hydraulic cement. Due to greater water volume and pressure in the west (heavy) bay, the wall separating the middle and west bays is higher and wider than the wall separating the light (eastern) bay from the middle bay. The middle bay also has a wood (Red Oak) tumble gate at its northern edge adjacent to the dam. The gate (similar to the light dock) is attached to a double winch-and-pulley system mounted to a stone wall, shared between the light and middle bays. The gate has two rectangular slide gates at the bottom and a wooden case filled with stone at the top. The wood apron south of the fate was rebuilt over the sluiceway. Six original oak cradle beam posts are present in the floor of the bay, and covered in vegetation. The floor of the bay often displays minor flooding following rain or in wet conditions.

Figure 3.31. Middle bay of the dry dock - view north. (Photo by EDR, 2013)

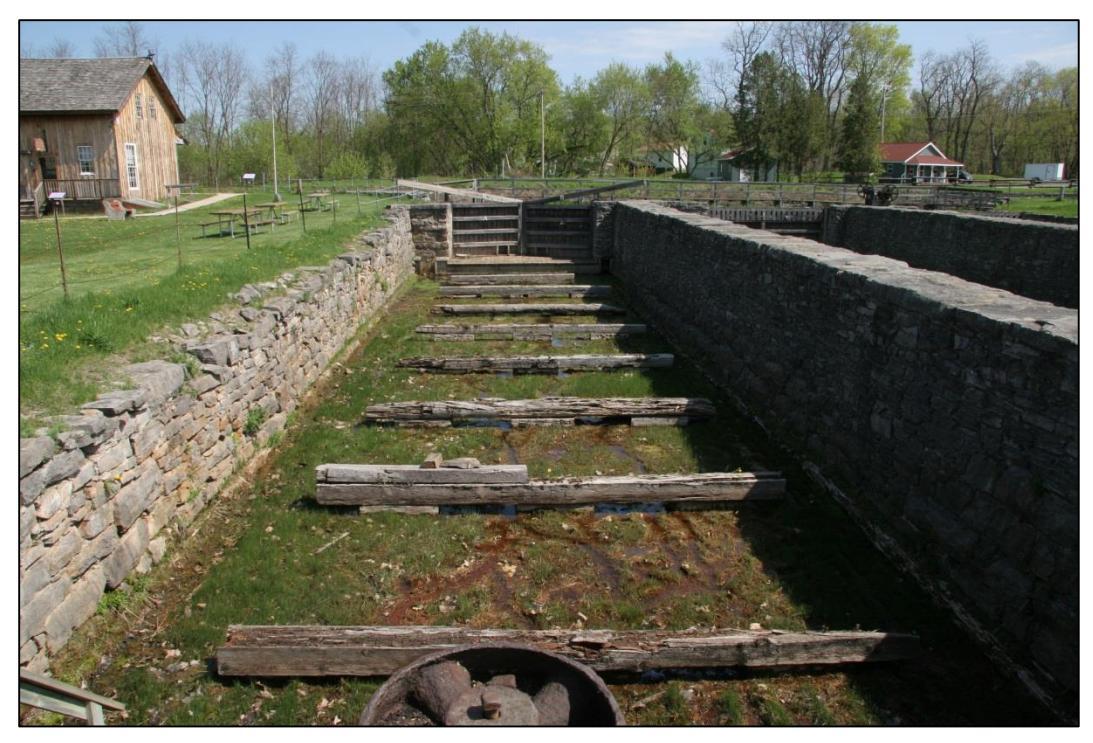
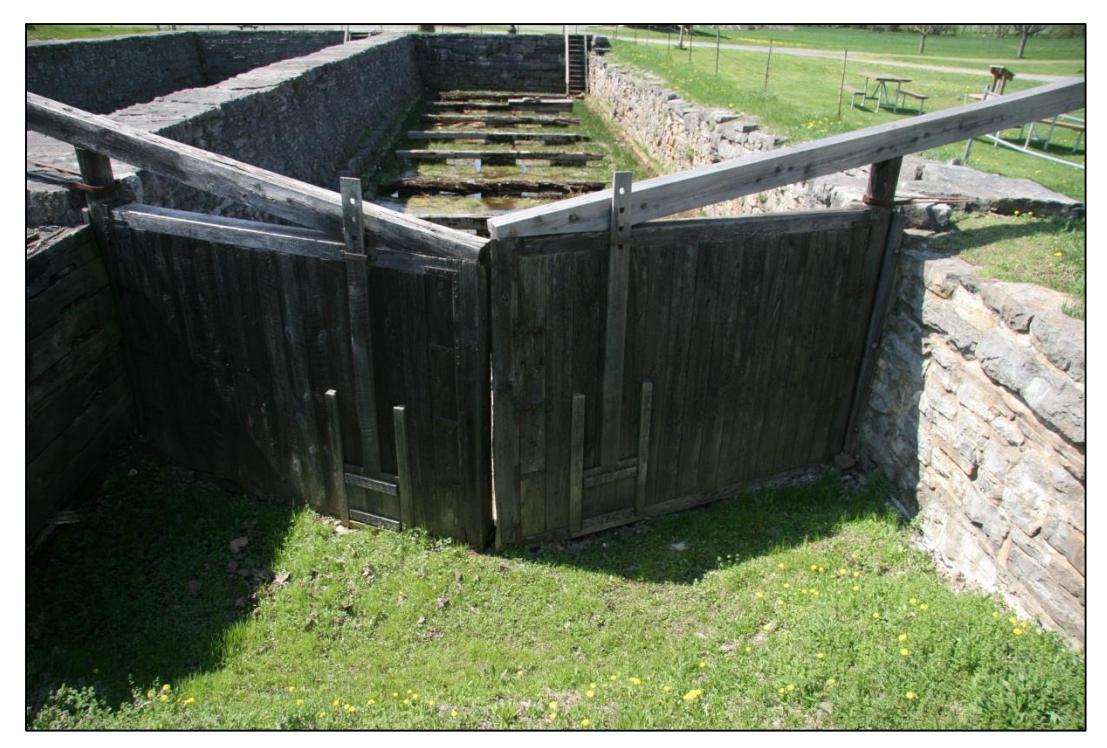
The west, heavy or loaded bay (Figures 3.32. and 3.33) was intended for the repair of fully-loaded canal boats and measures 25 ½ feet wide at its base, 107 feet at its maximum length with a depth of eight feet. The south, east, and west walls of the bay are constructed of limestone and hydraulic cement. All of the walls of the loaded bay needed to be of heavier construction to withstand the increased water pressure resulting from the greater depth and corresponding greater volume of water in the bay (when it was full). Eight original oak cradle beams are present at the bottom of the heavy dock, with some original oak and concrete flooring present beneath the beams. The west wall of the heavy bay is largely composed of original masonry and appears largely as it was when uncovered in 1986, as it had not experienced as much loss of original material as the stone walls of the light and middle bays. Capstones are absent from most of the top of the west wall of the heavy bay. The wood apron at the north end of the bay has been rebuilt atop the sluiceway. The heavy bay displays a miter style wood (Red Oak) gate at its northern edge adjacent to the dam and walkway. The wood gate has two rectangular slide gates (one on each gate panel) located at the bottom.

Figure 3.32. Heavy bay of the dry dock - view south. (Photo by EDR, 2013)

Figure 3.33. Heavy bay of the dry dock - view north. (Photo by EDR, 2013)

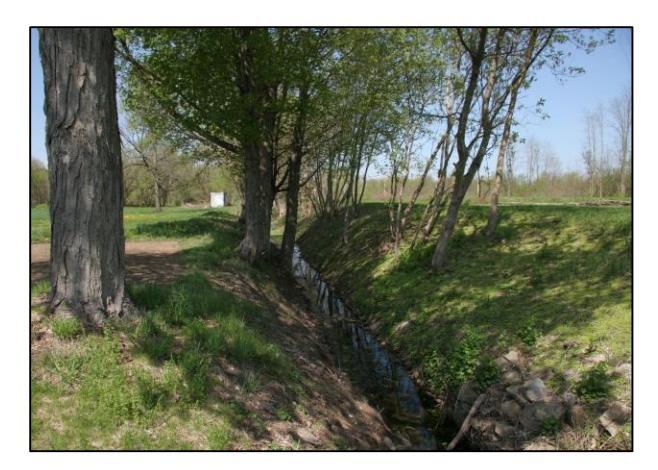
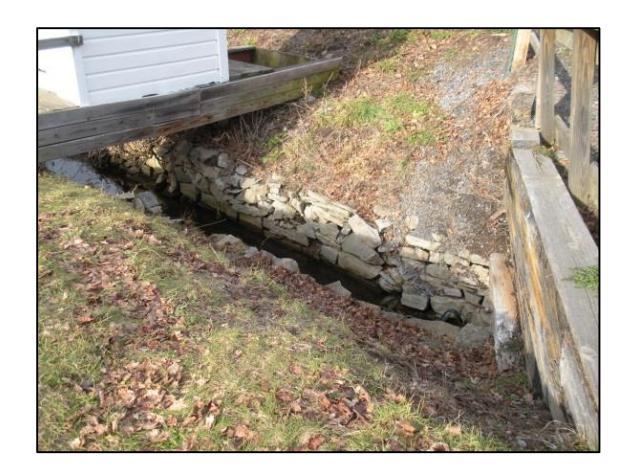
Figure 3.34. (left). Sluiceway – view west. (Photo by EDR, 2013) Figure 3.35. (right). Sluiceway – stacked stone walls. (Photo by EDR, 2013)

Sluiceway – The sluiceway runs parallel to the Enlarged Erie Canal, traversing approximately 1,700 feet from the northwestern corner of the west (heavy) bay of the dry dock and terminating at Chittenango Creek. For the first 150 feet (130 of which are underground), the sluiceway is a four foot-by-four foot box tunnel with dry-laid limestone walls rebuilt by museum volunteers in 1989. The sluiceway, between the end of the tunnel and Chittenango Creek, is a narrow, vegetated, open ditch with steep sloping sides reinforced with dry-laid fieldstone retaining walls (Figures 3.34 and 3.35).
