Existing Conditions Assessment

Casparus F. Pruyn House

207 Old Niskayuna Road, Town of Colonie, Albany County, New York

September 2016

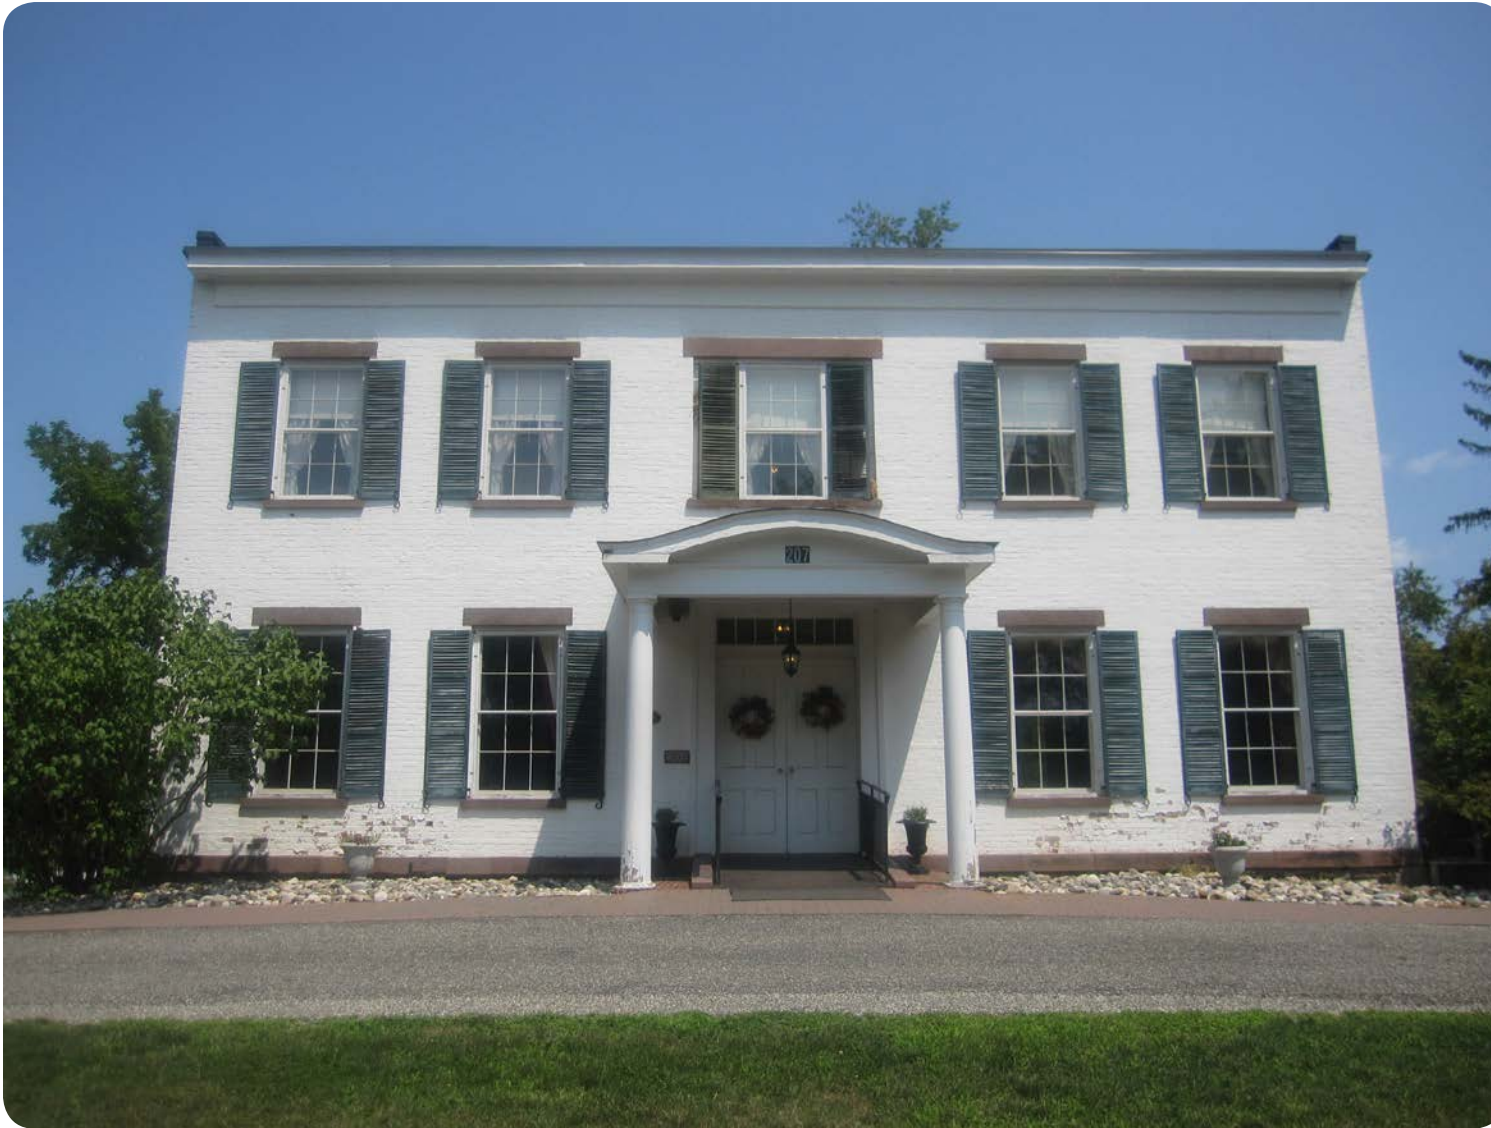
Photo 1

Front elevation cornice: The white-painted cornice and frieze board of the east elevation have been in place, and painted, since at least the early twentieth century (Appendix C, Photograph 2). Today they appear much the same (Appendix B, Photograph 1.) There is no evidence of wood deterioration, thanks to the drip edge which extends beyond the wood.

Front Elevation, view to the northeast.

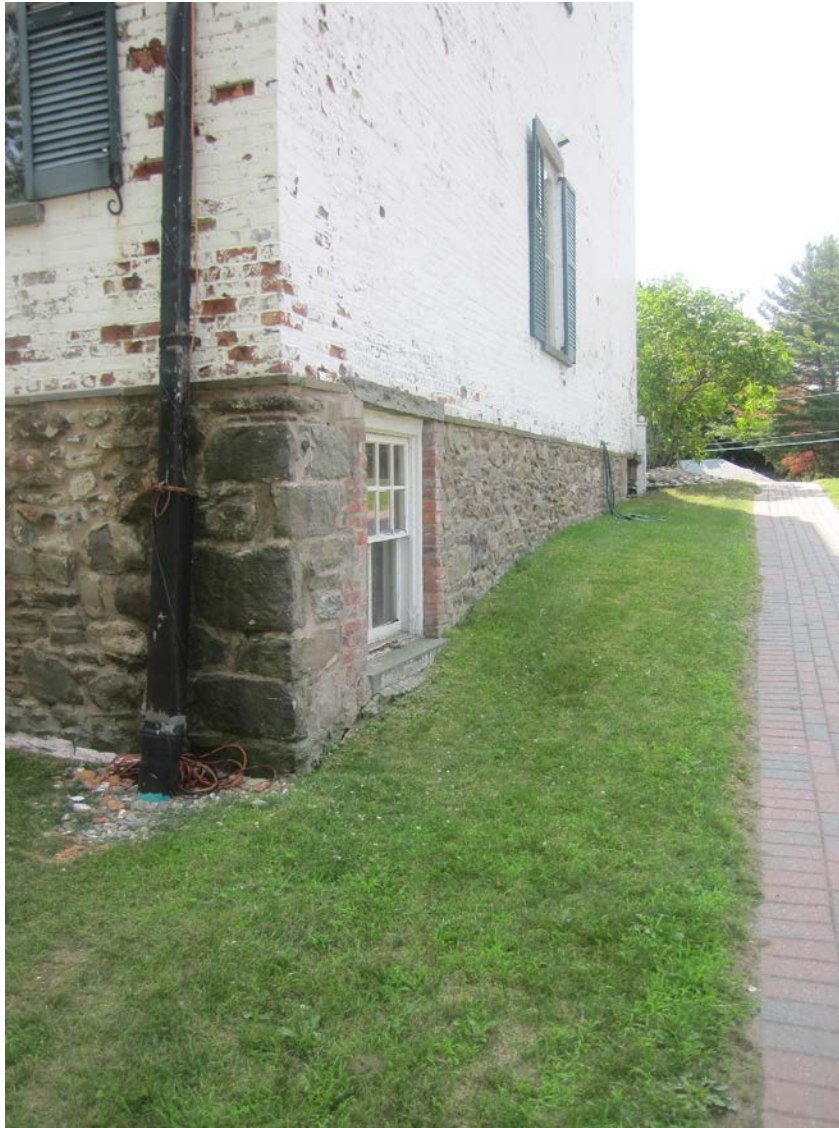
Photo 10

Grade at north elevation, view to the southwest.

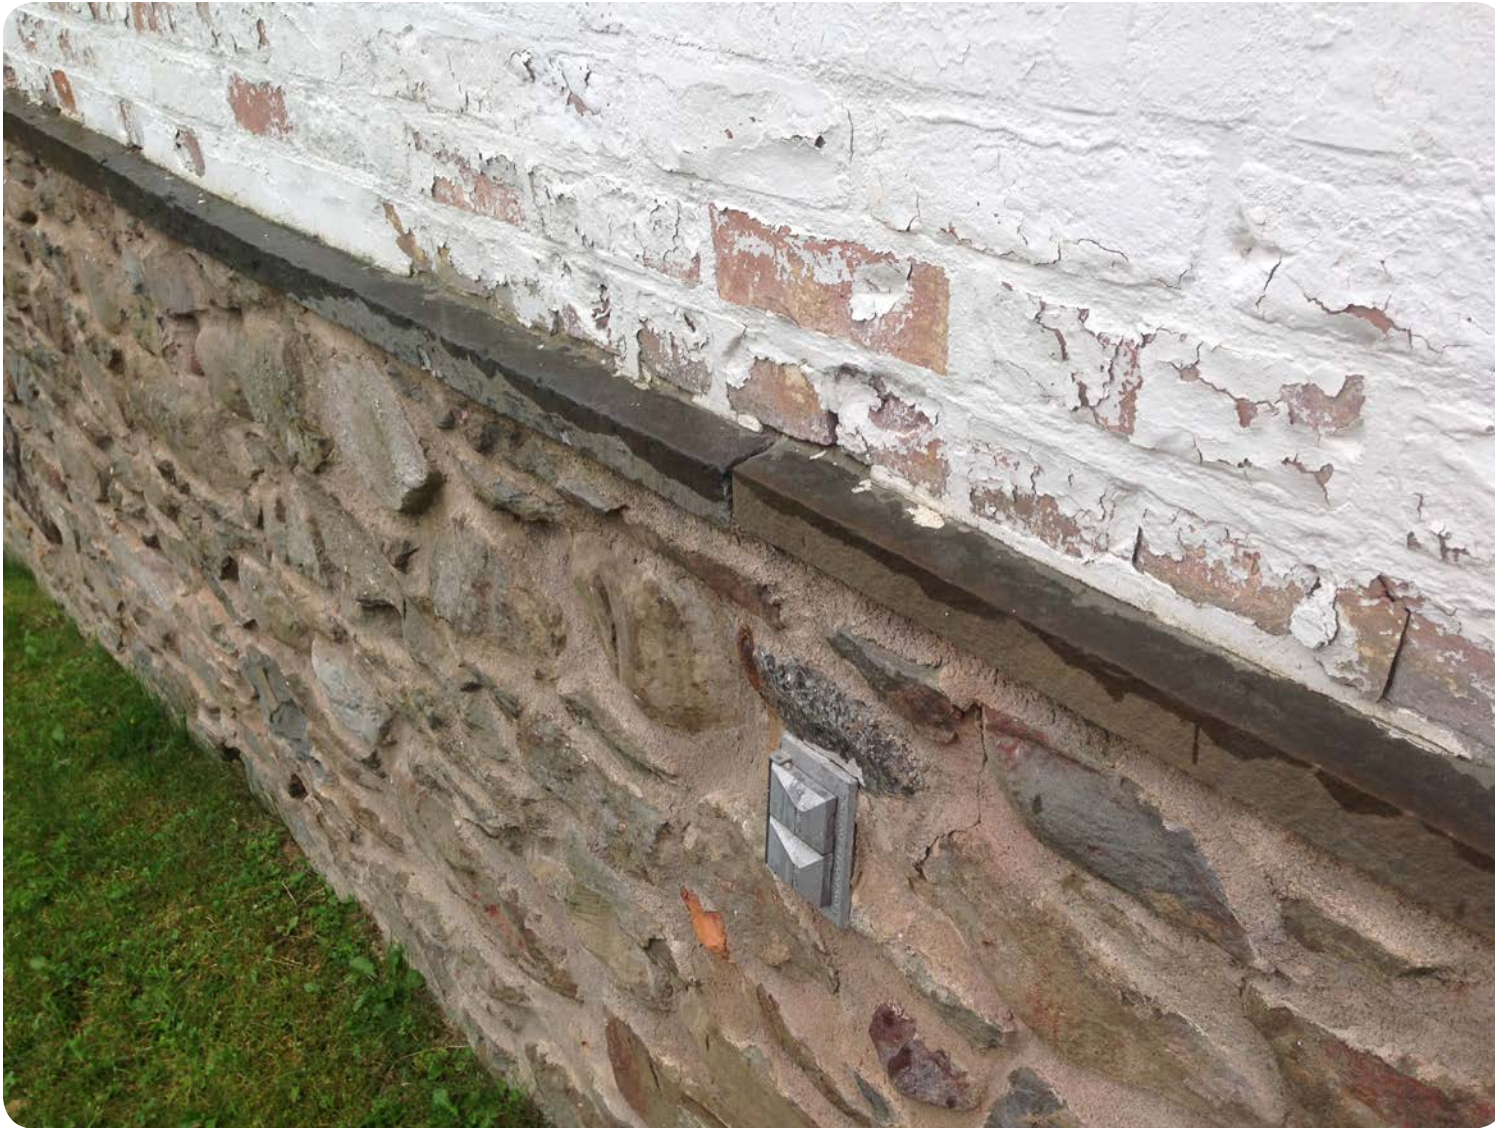
Photo 12

The band course above the foundation also receives water from the drip edge (Appendix B, Photograph 12). In places where a significant amount of water flow over the slate, such as the northeast corner (Appendix B, Photograph 13), the stone is beginning to show signs of deterioration.

Rainy conditions. North elevation detail.

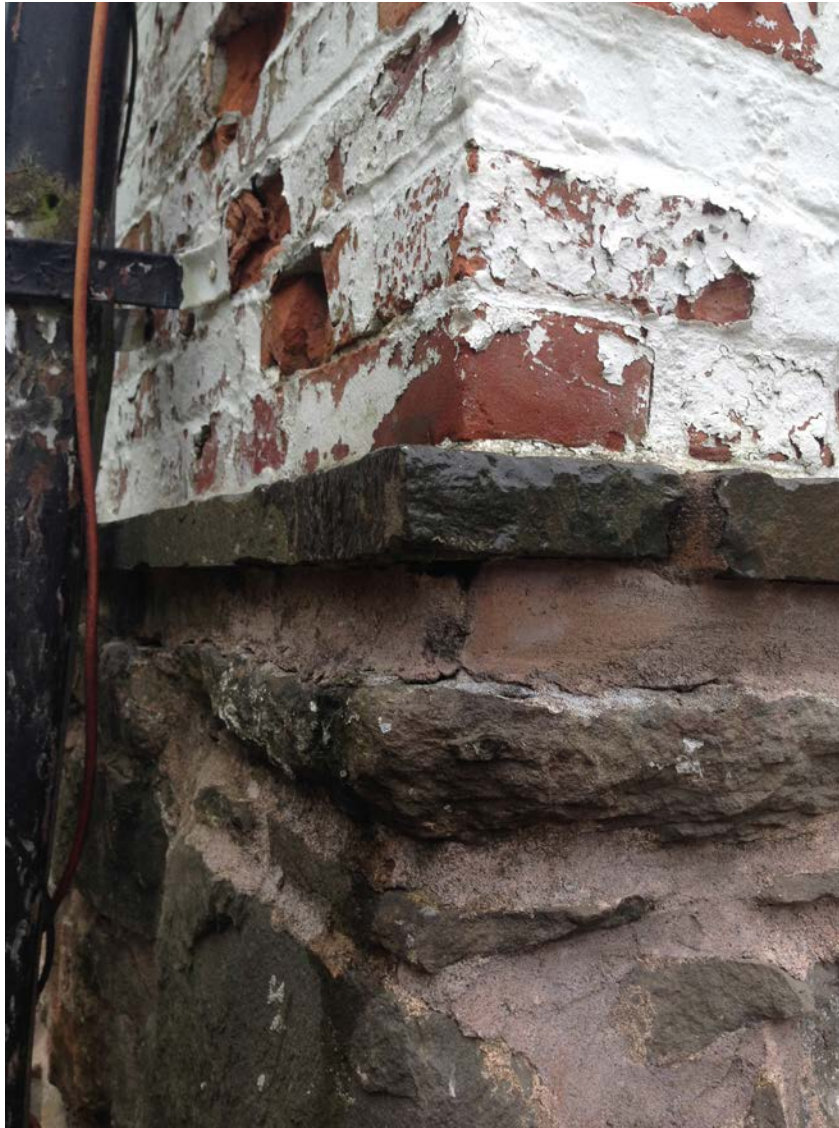
Photo 13

Rainy conditions. Northeast corner detail.

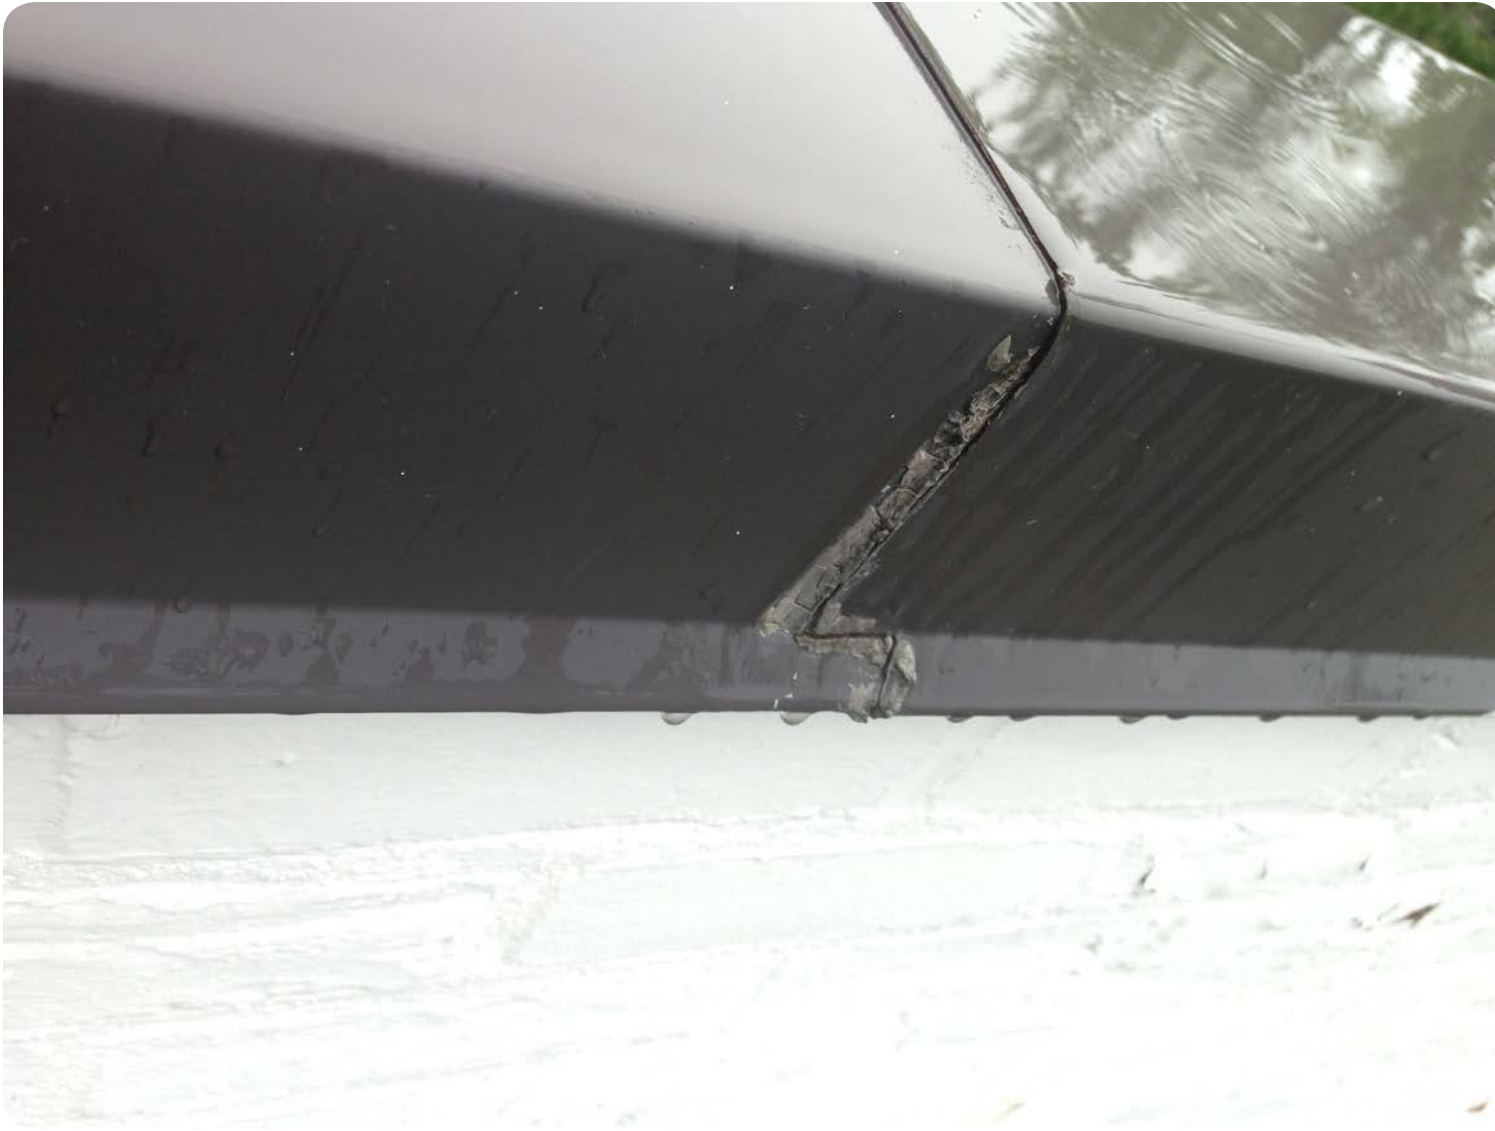
Photo 17

Rainy conditions. Coping detail.

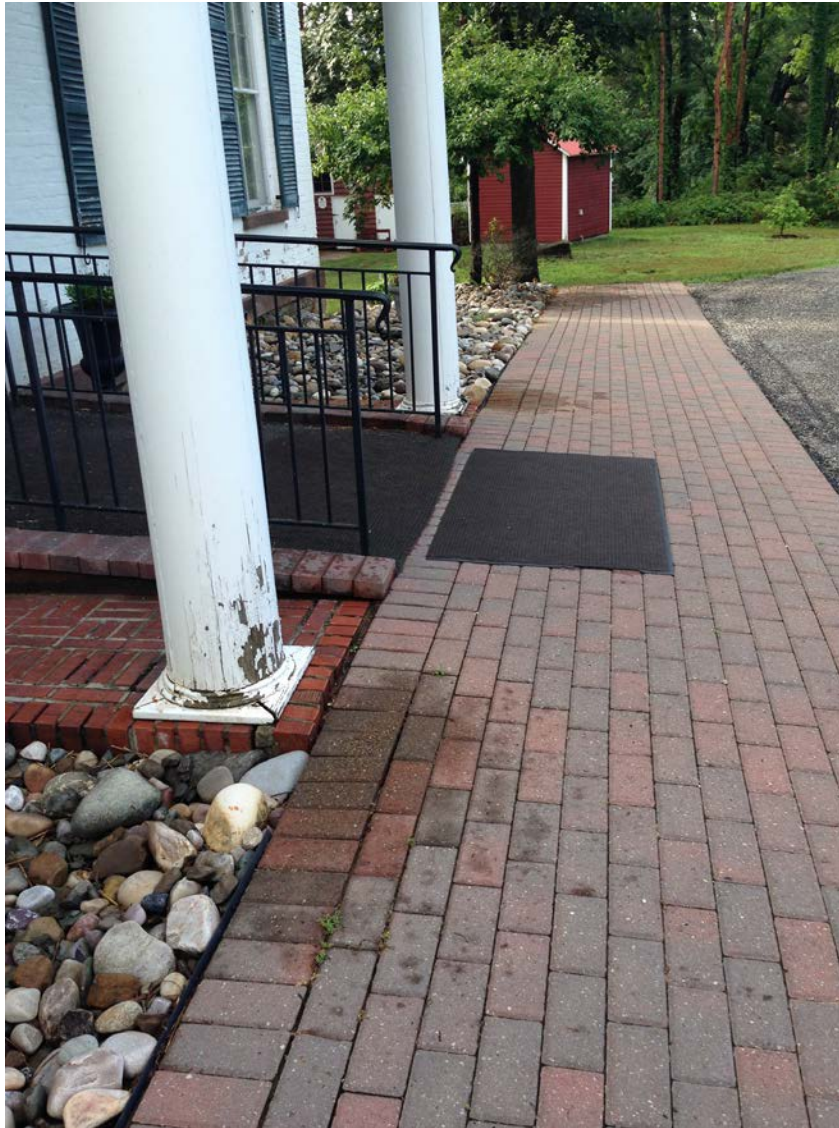
Photo 18

Rainy conditions. Lower portico detail.

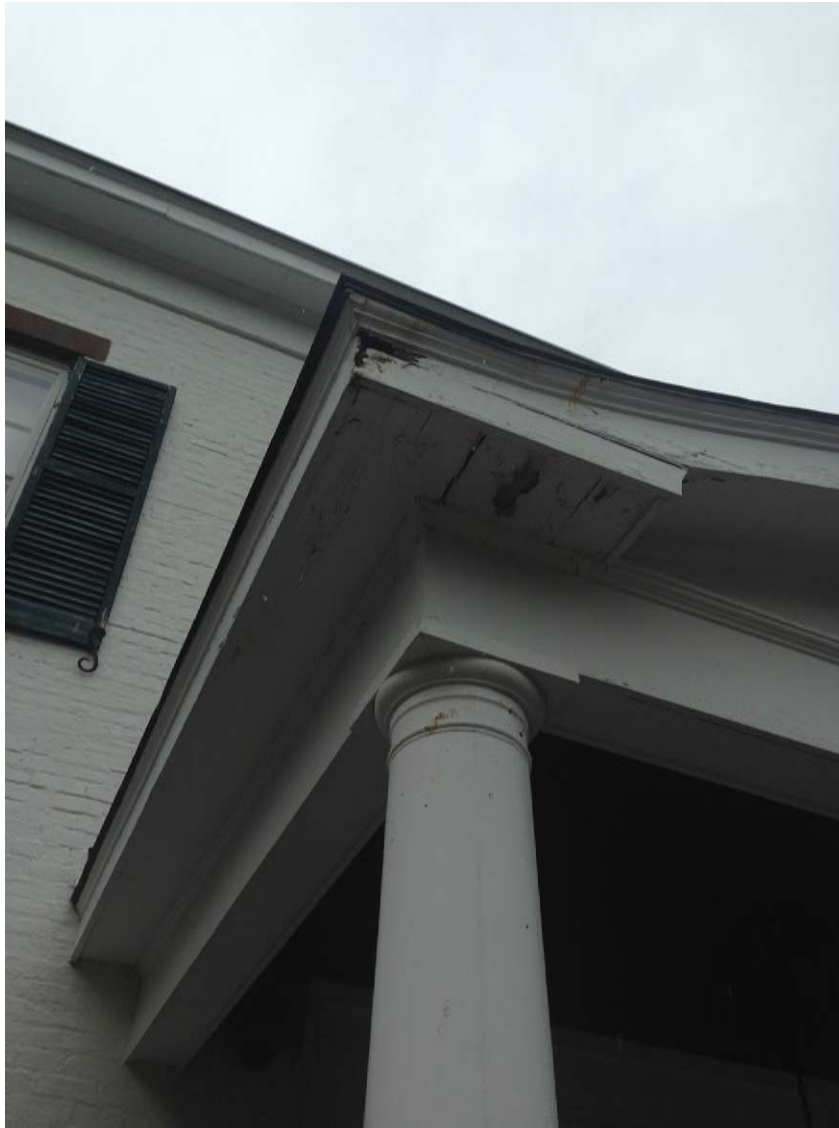
Photo 19

Entrance Portico: There has been no architectural work executed at the portico in the past decade at minimum, and likely dates back to 1992. At the front elevation (Appendix B, Photograph 1), water shedding is a problem at the portico roof, whose metal drip edge releases rain water so close to the wood columns, that splash-back has eroded the paint at their bases, and is now causing wood deterioration (Appendix B, Photo 18). This is a similar condition to what is found at the upper corners of the portico, where some water is not being dripped off the edge, and instead washes down the wood fascia (Appendix B, Photo 19).

Rainy conditions. Upper portico detail.

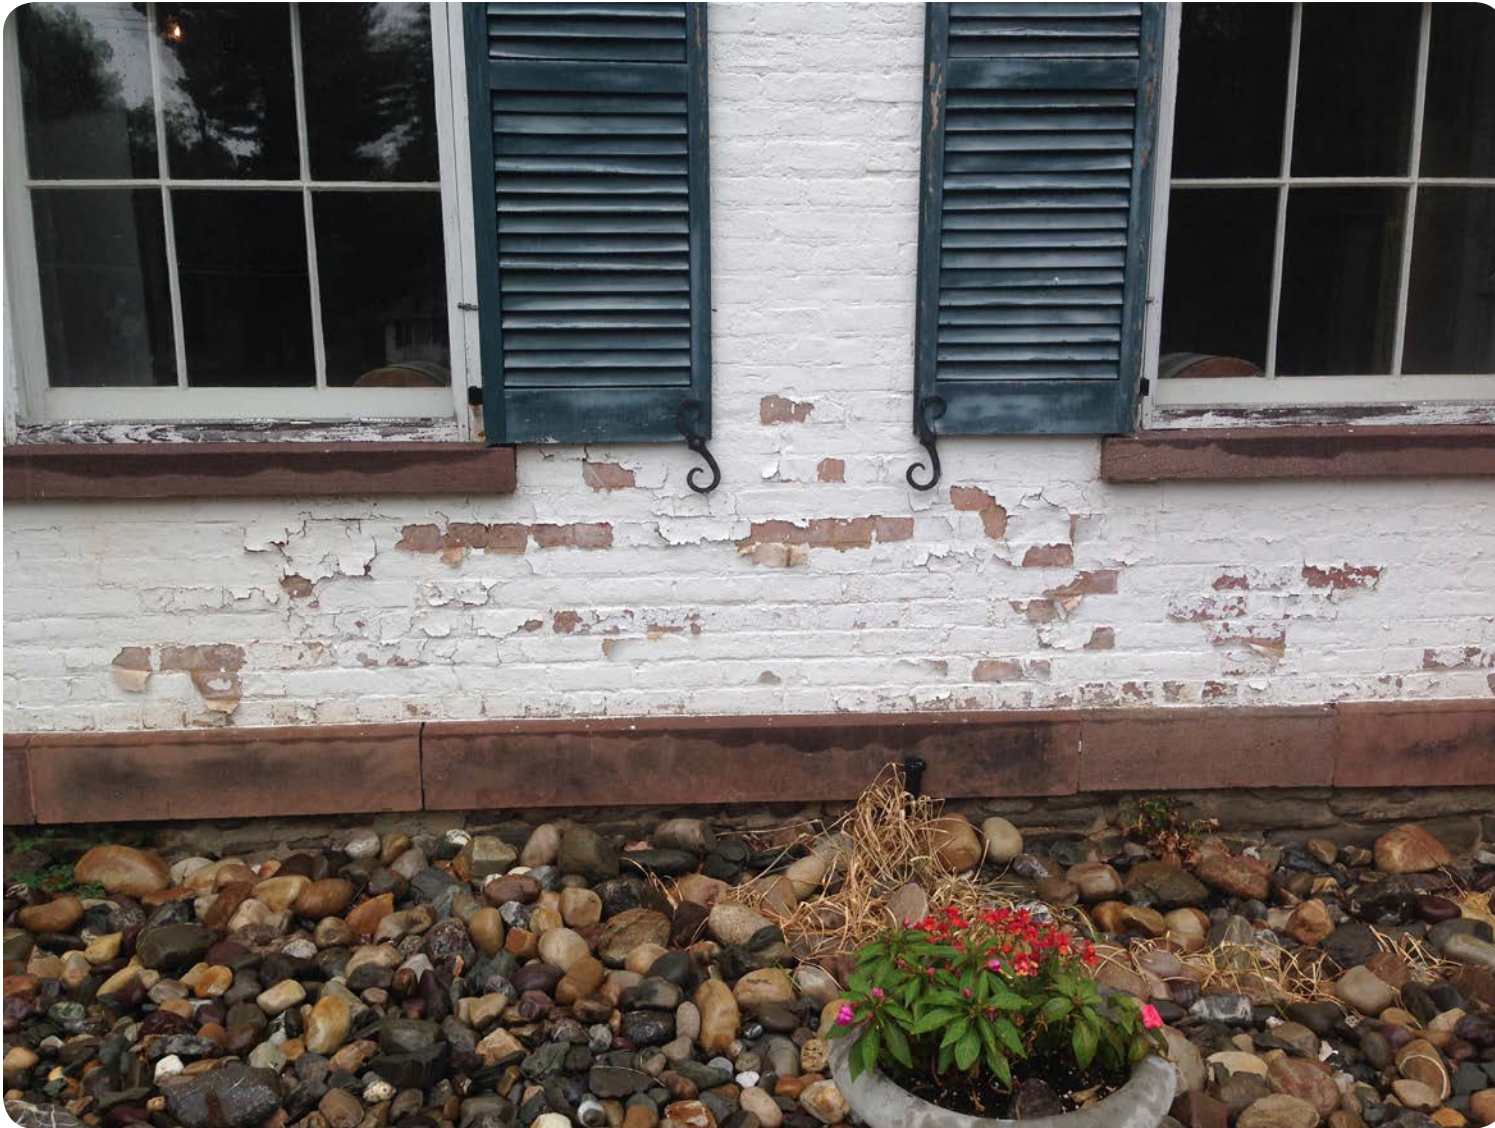
Photo 20

Rainy conditions. West elevation detail.

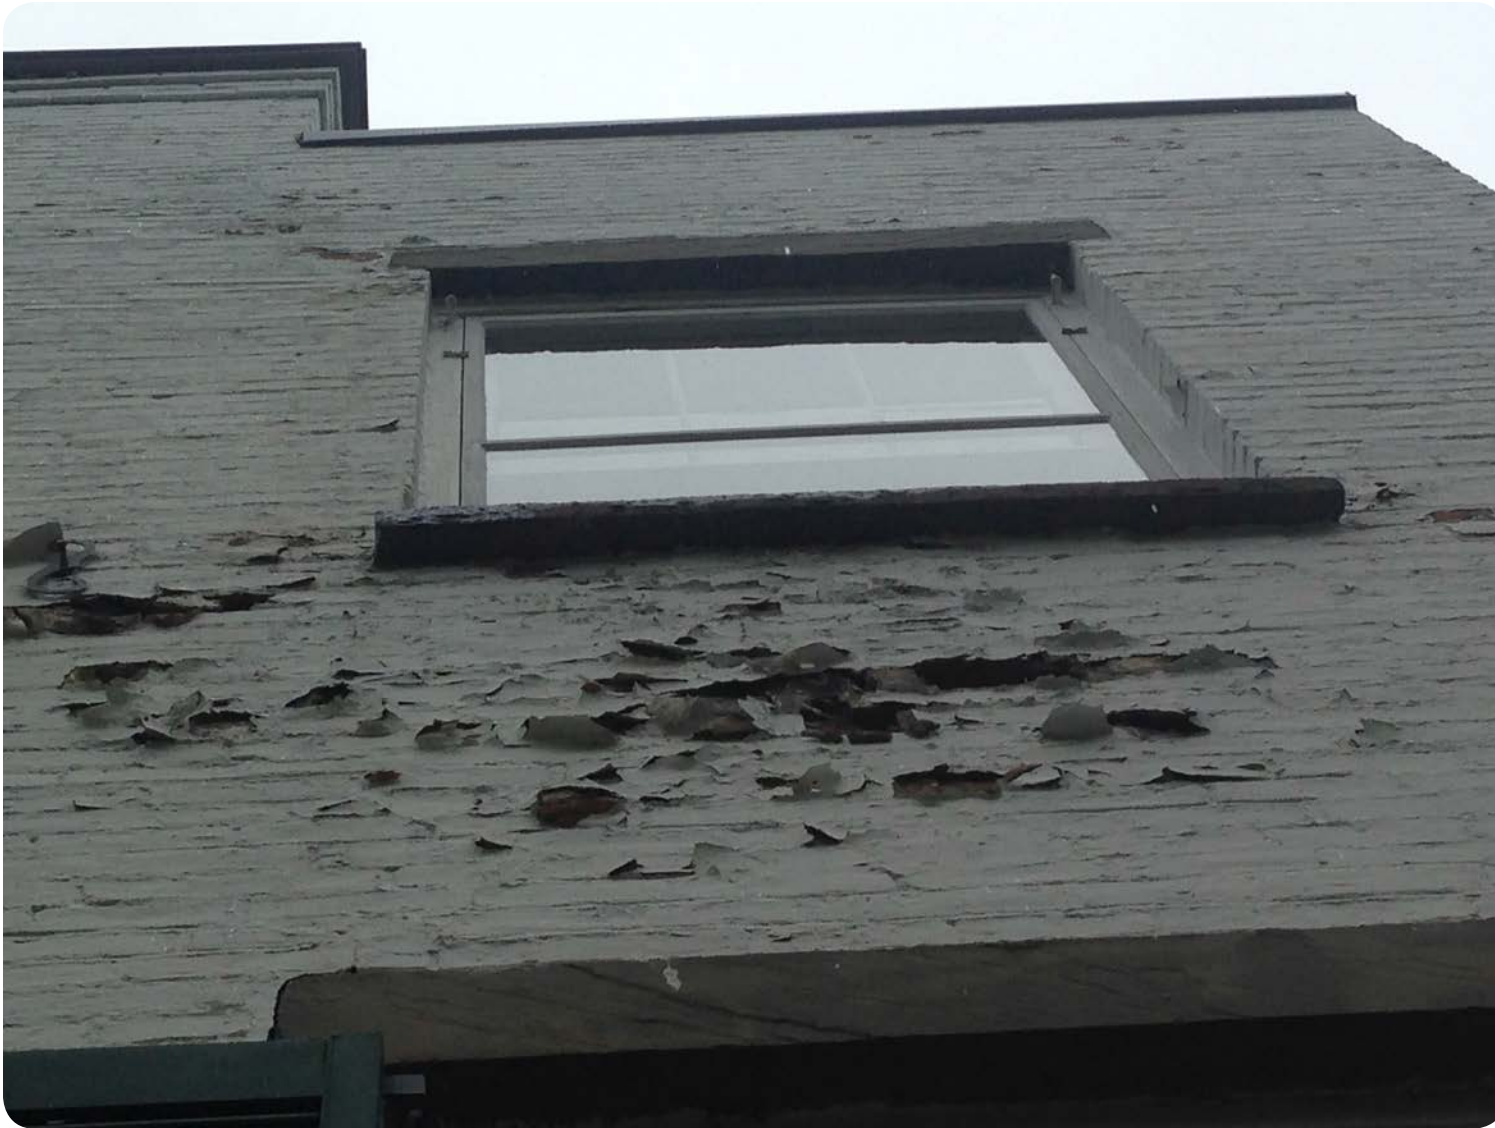
Photo 21

Rainy conditions. South elevation detail.

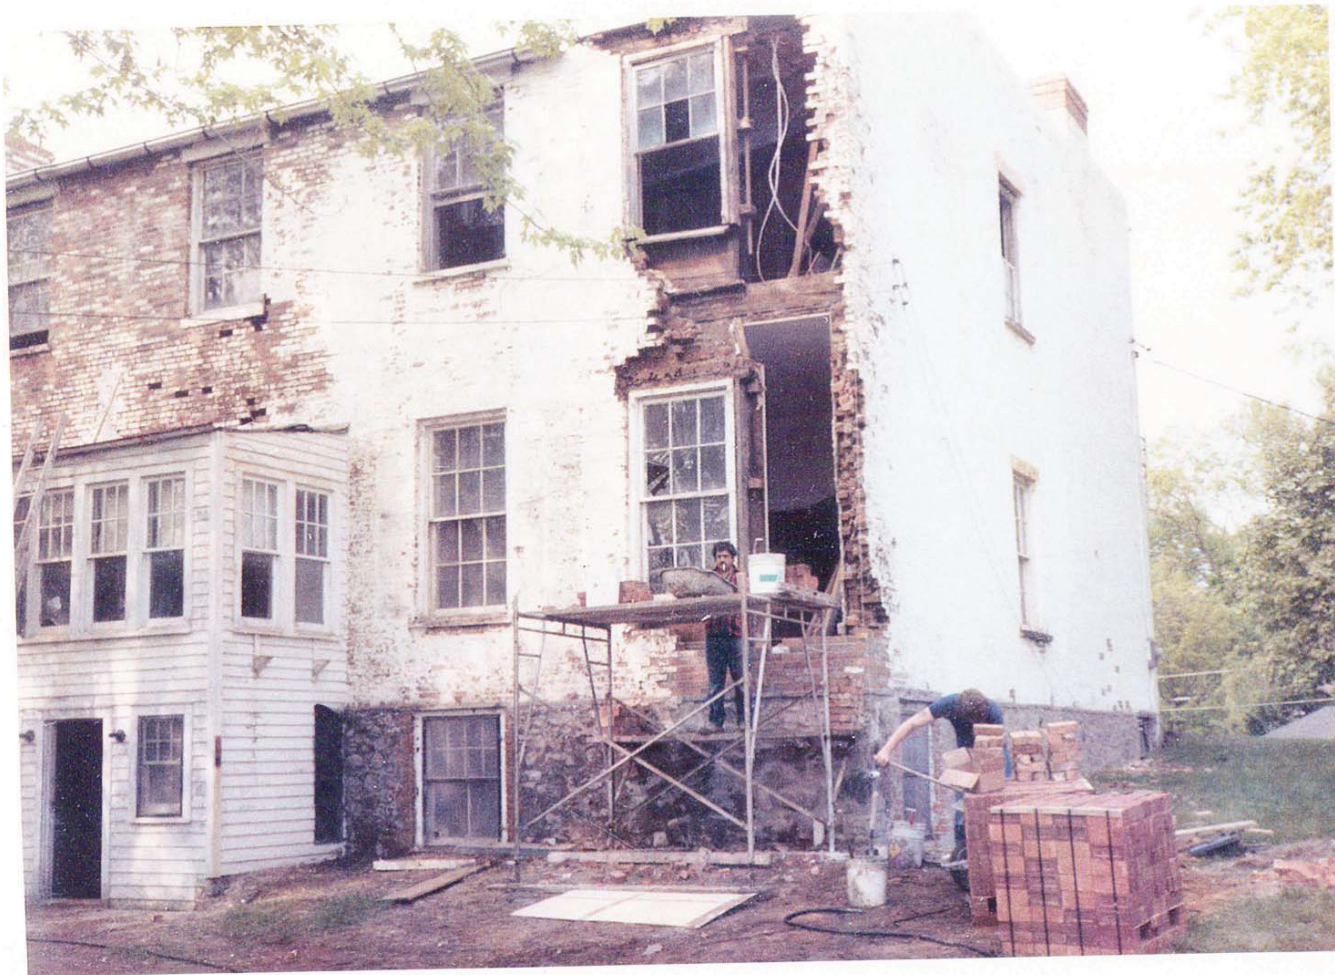
Photo 9

Reconstruction and Venting: Portions of the brick walls in various locations were reconstructed during the Town's ownership and include the northern parapet (Appendix C, Photograph 10) and the northern edge of the rear elevation from foundation to roofline (Appendix C, Photograph 9). In 2007, the area between the chimneys above the second floor windows were reconstructed with additional vents with the idea that moisture within the wall would have a space to escape (Appendix B, Photograph 3). Vents are typically reserved for cavity wall construction that have airspace behind veneer brick, and weep holes near the foundation, allowing for air circulation to assist water out of the envelope. In the case of a solid brick wall, vents are likely serving as entranceways for water to get into the parapet wall, without a means to escape.

1984 Photograph. Demolition of deteriorated brick, northeast corner.

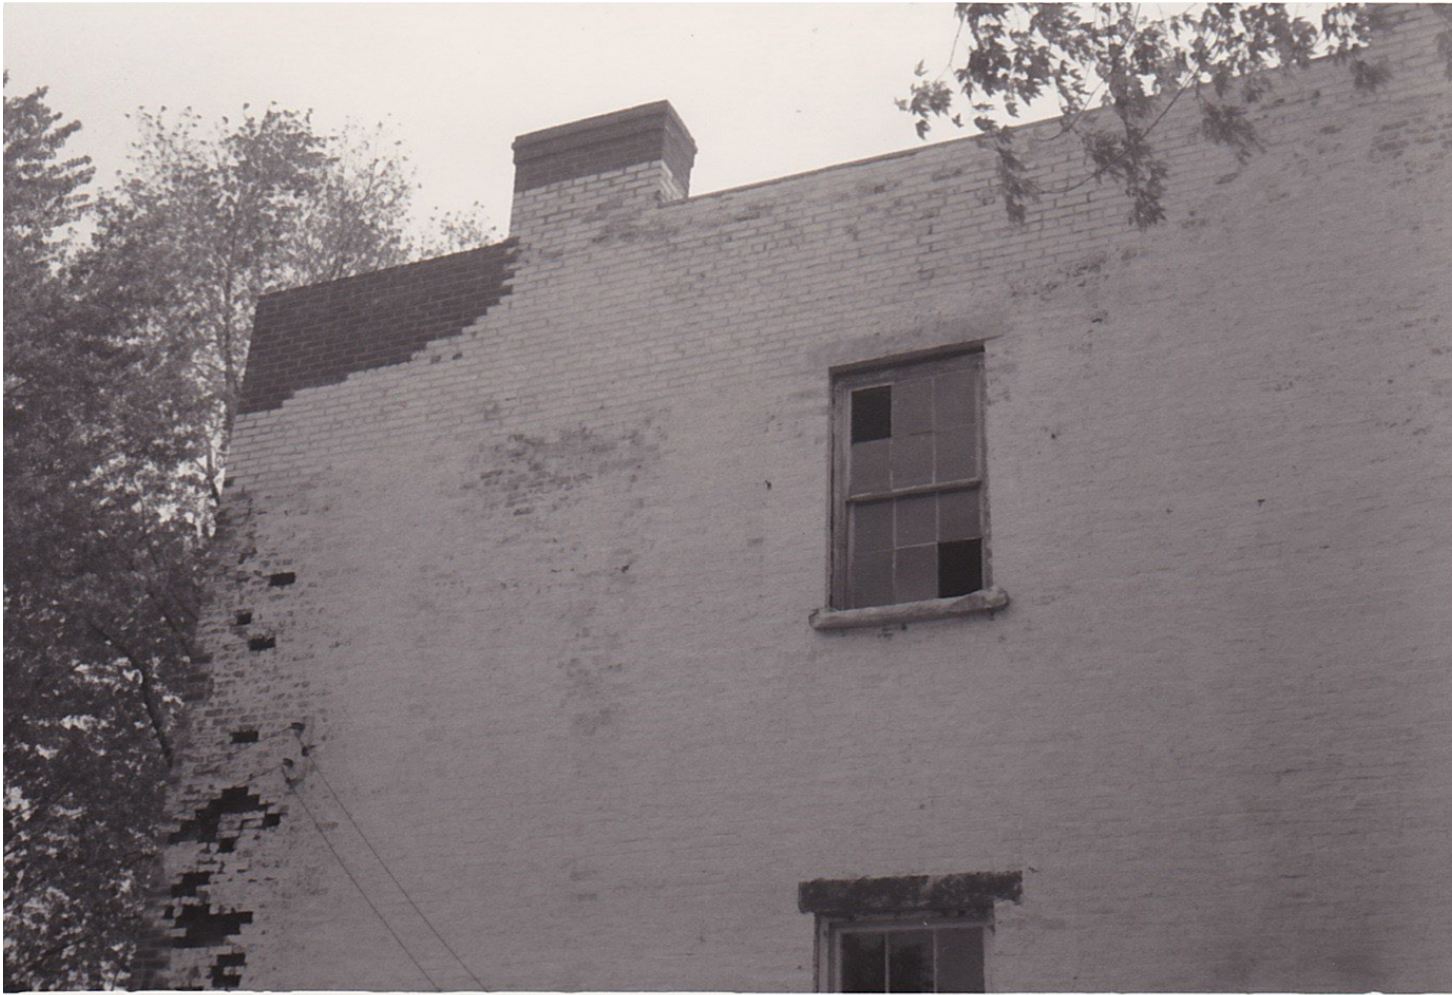
Photo 10

South and North elevations: At the time of the building's purchase, the north and south elevations exhibited brick problems, much of it due to the lack of roofing along the inside face of the parapet wall which was later corrected. (Appendix C, Photographs 5 and 10).

1984 Photograph. Reconstruction of parapet, northeast corner.

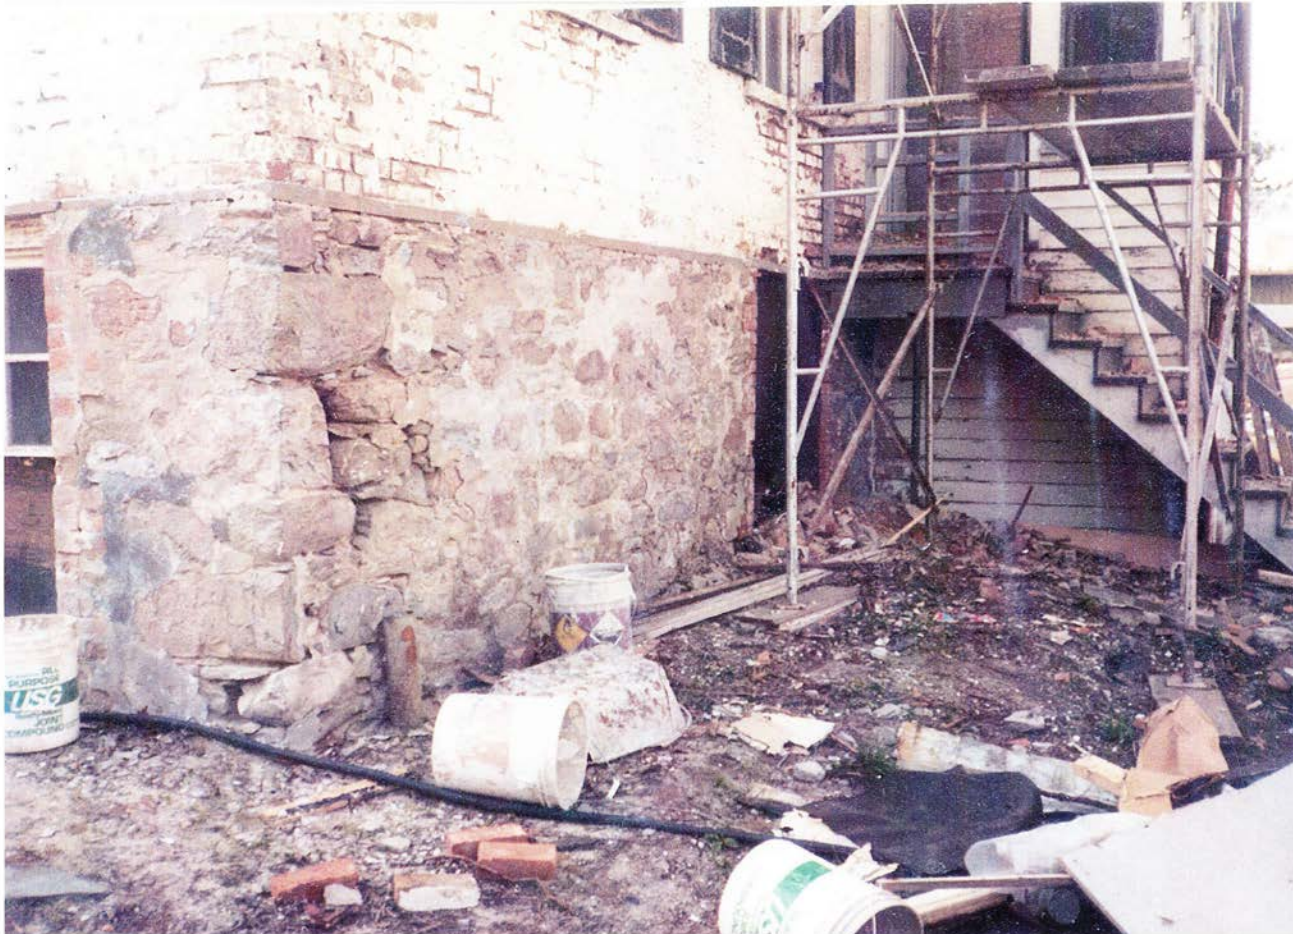
Photo 11

Brick and Mortar: Most of the original soft historic brick remains at the Pruyn House, but over time, the removed units have been replaced with a harder machined brick. Similarly, much of the soft historic lime mortar has been removed and replaced using modern mixes (Appendix C, Photograph 11). All brick surrounds at basement

1984 Photograph. Portland cement repointing. South side of rear elevation.

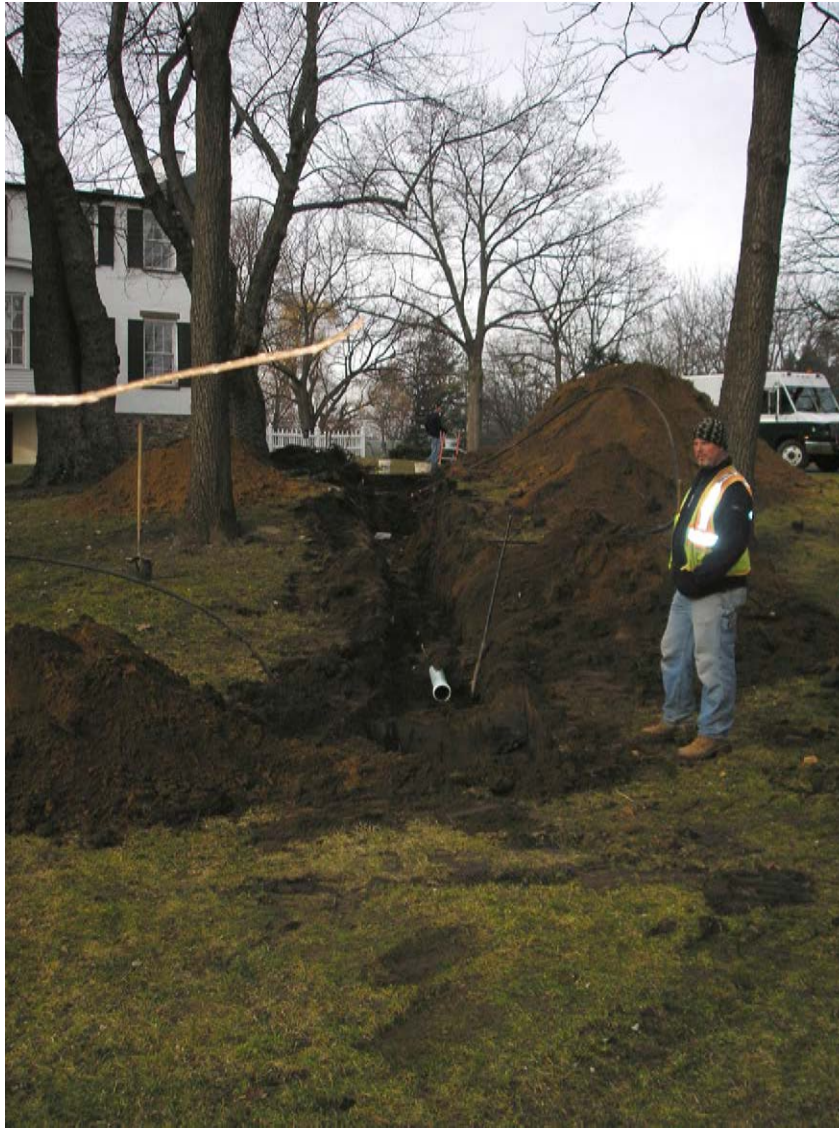
Photo 15

- 2007 Front ramp installed. (Appendix C, Photograph 14)
- 2009 Underground drainage pipe failure at northeast corner downspout. Trench dug, new pipe installed. Southeast underground drainage pipe has breakage 40' away from building, no repair made at that location. (Appendix C, Photograph 15)

2009 Photograph. New drainpipe installed at rear of building.

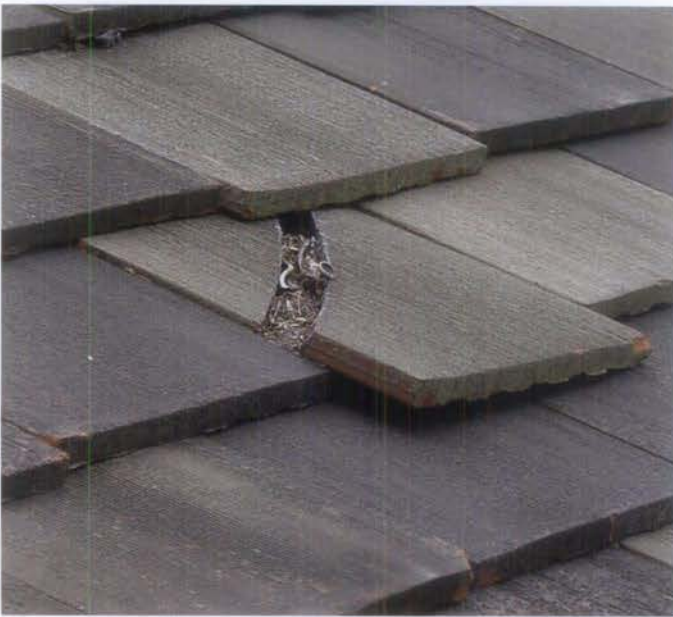
Figure 4. Damage to roofs often requires immediate attention. As a temporary measure, this damaged roof tile could be replaced with a brown aluminum sheet wedged between the existing tiles. Photo: Chad Randl.

- As a temporary measure, slip pieces of non-corrosive metal flashing under or between damaged and missing roofing units until new slate, shingles, or tile can be attached. Repair broken, missing or damaged roofing units with ones that match. Follow roofing supplier and industry guidance on inserting and attaching replacement units (Fig 4). Avoid using temporary asphalt patches as it makes a proper repair difficult later on.

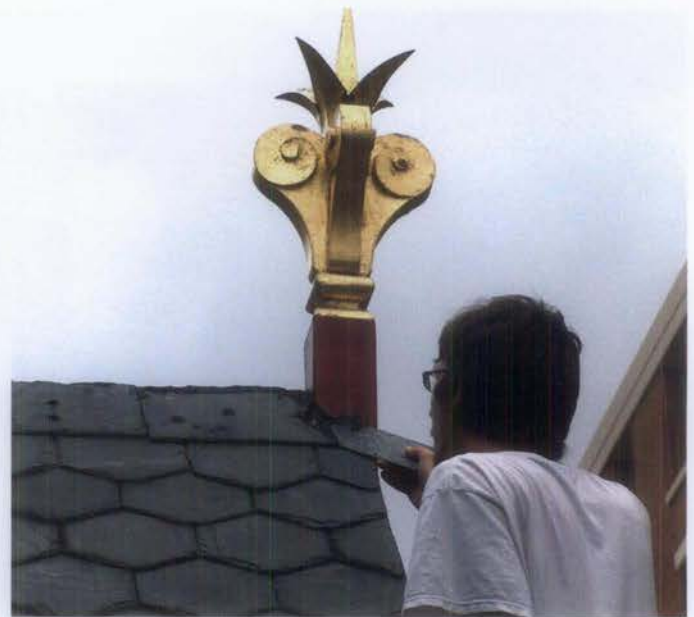
Figure 5. The use of a sealant to close an exposed joint is not always an effective long-term solution. Where this decorative wood element connects to the slate roof, the sealant has failed within a short time and a proper metal flashing collar is being fitted instead. Photo: Bryan Blundell.

- Re-secure loose decorative elements, such as finials and weathervanes. Seek professional advice if decorative elements exhibit considerable corrosion, wood rot, or structural instability. Small surface cracks may benefit from a flexible sealant to keep moisture out; sealants have a limited life and require careful inspection and periodic replacement (Fig 5).

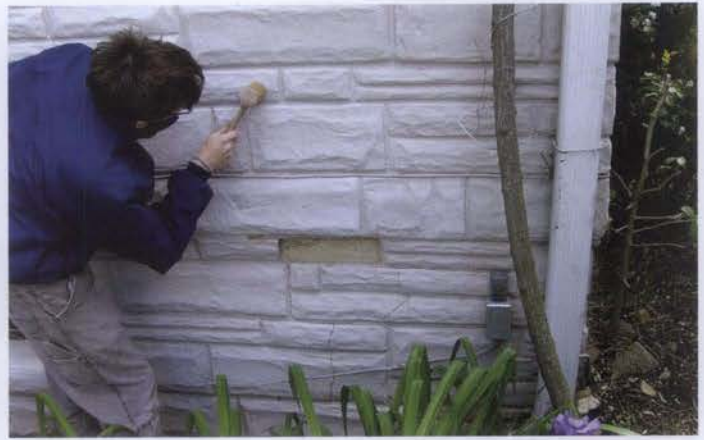
Figure 6. Stucco applied to an exterior wall or foundation was intended to function as a watertight surface. Unless maintained, rainwater will penetrate open joints and cracks that may occur over time. A spalled section of stucco indicates some damage has occurred and a wooden mallet is being used to tap the surface to determine whether the immediate stucco has lost adhesion. Photo: Bryan Blundell.

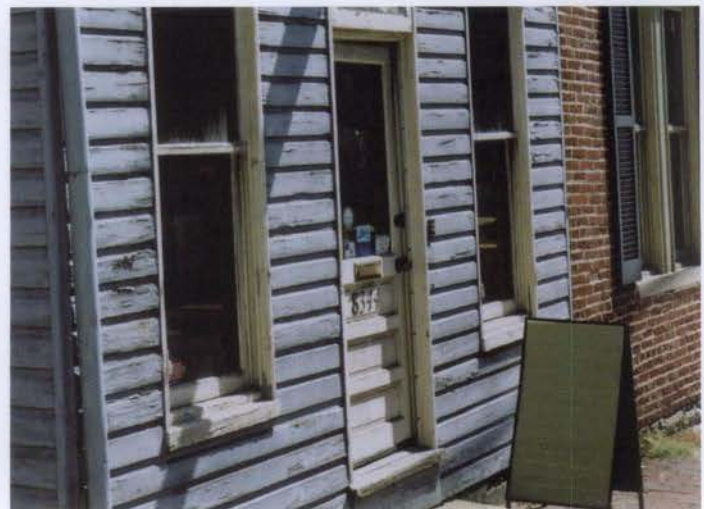
Figure 8. The paint on the siding of this south-facing wall needs to be scraped, sanded, primed and repainted. Postponing such work will lead to further paint failure, require greater preparatory costs, and could even result in the need to replace some siding. Photo: Charles Fisher.

- Prepare, prime, and spot paint areas needing repainting. Remember that preparation is the key to a successful long lasting paint job. Ensure beforehand the compatibility of new and existing paints to avoid premature paint failure. Remove loose paint to a sound substrate; sand or gently rough surface if needed for a good paint bond; wipe clean; and repaint with appropriate primer and topcoats. Follow manufacturer's recommendations for application of coatings, including temperature parameters for paint application. Use top quality coating materials. Generally paint when sun is not shining directly onto surfaces to be painted.

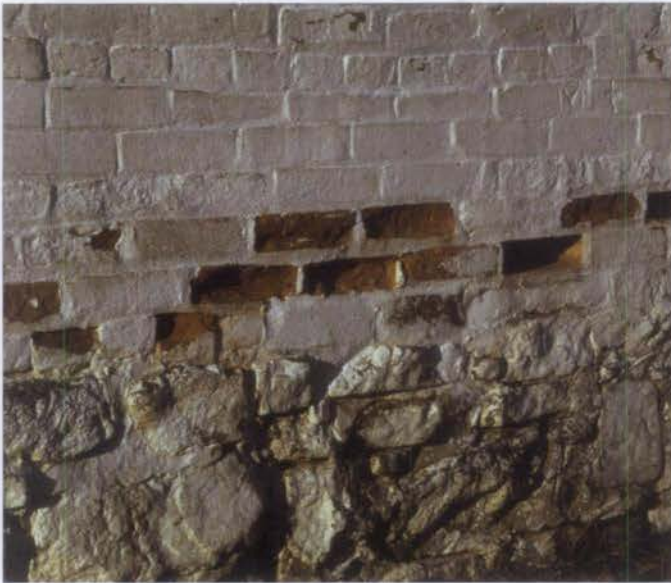
Figure 10. Repointing of masonry should usually be approached as repair rather than maintenance work in part because of the need for a skilled mason familiar with historic mortar. In this case, a moisture condition was not corrected and the use of a waterproof coating and off-the-shelf Portland cement mortar trapped water and resulted in further damage to these 19th century bricks. Photo: NPS files.

- Repoint masonry in areas where mortar is loose or where masonry units have settled. Resolve cause of cracks or failure before resetting units and repointing. Rake out joints by hand, generally avoiding rotary saws or drills, to a depth of 2 ½ times the width of the joint (or until sound mortar is encountered), to make sure that fresh mortar will not pop out. Repointing mortar should be lime-rich and formulated to be slightly weaker than the masonry units and to match the historic mortar in color, width, appearance, and tooling. Off-the-shelf pre-mixed cement mortars are not appropriate for most historic buildings. Avoid use of joint sealants in place of

mortar on vertical masonry wall surfaces, as they are not breathable and can lead to moisture-related damage of the adjacent masonry (Fig 10).

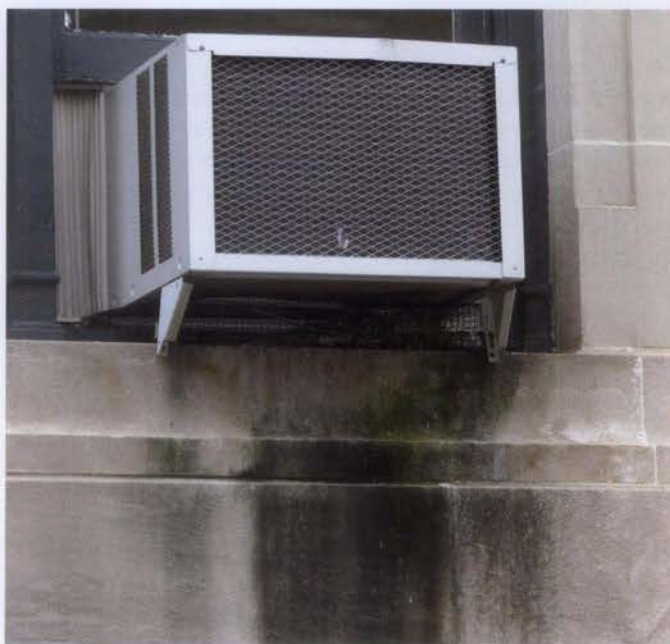
Figure 13. Window air conditioning units can cause damage to surfaces below when condensation drips in an uncontrolled manner. Drip extension tubes can sometimes be added to direct the discharge.

- Remove debris beneath window air conditioning units and ensure that water from units does not drain onto sills or wall surfaces below (Fig 13). Removal of air conditioning units when not in season is recommended.

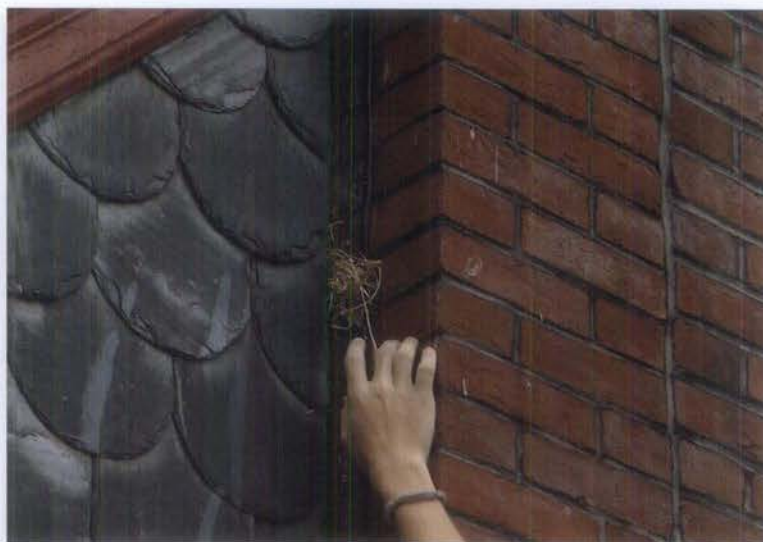
Figure 14. When inspecting connections between projections and the main building, look for areas where birds, bees and pests may enter or nest. Birds have been nesting in this porch roof and the area is being cleaned of their debris. Where an opening exists, it may be necessary to cover it with a trim piece, screening, or sealant. Photo: Bryan Blundell.

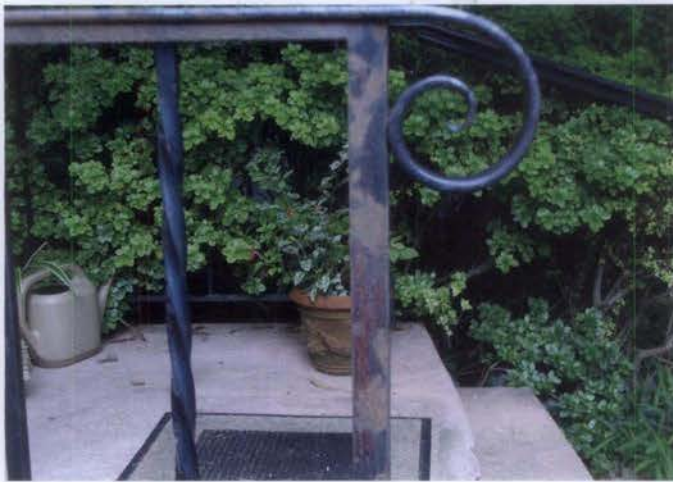
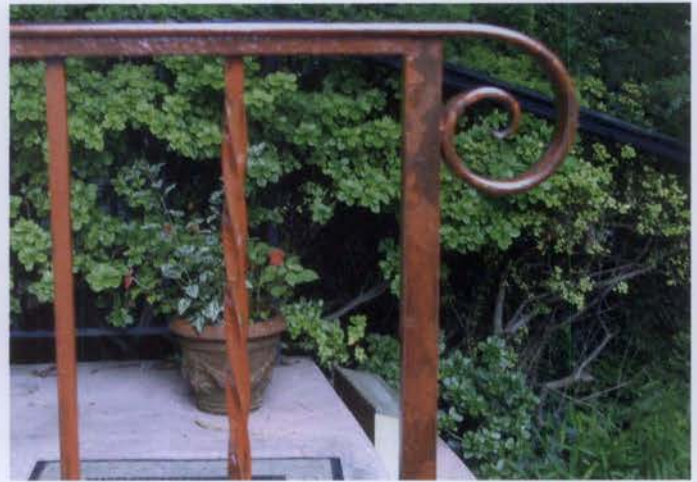
Figure 15. Metal projecting elements on a building, such as sign armatures and railings, are easily subject to rust and decay. Proper surface preparation to remove rust is essential. Special metal primers and topcoats should be used.

- Secure any loose connections, such as on porch rails or fire escapes.
- Maintain ferrous metal components by following manufacturer's recommendation for cleaning and repainting. Remove rust and corrosion from porch handrails, balconies, fire escapes, and other metal features; prepare, prime, and repaint using a corrosion-inhibitive coating system. Apply new primer before new corrosion sets in, followed by new topcoat. Take appropriate safety measures when dealing with existing lead-based paint and in using corrosion-removal products (Fig 15).
