Existing Conditions Assessment

Casparus F. Pruyn House

207 Old Niskayuna Road, Town of Colonie, Albany County, New York

September 2016

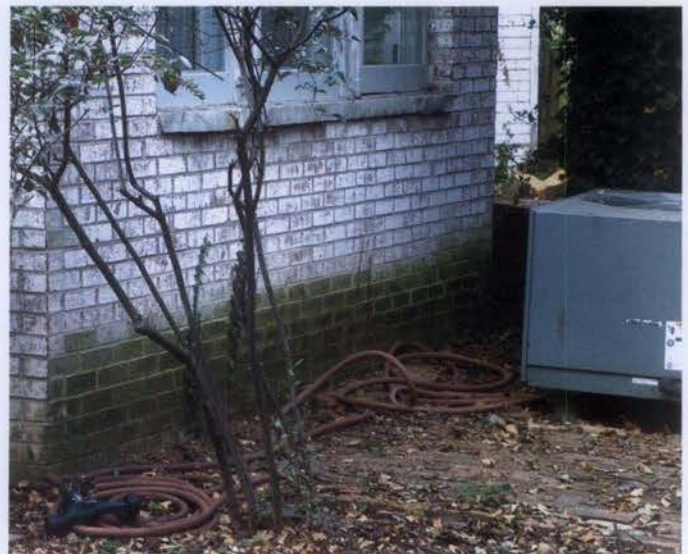
Figure 16. This chronically wet area has a mildew bloom brought on by heat generated from the air-conditioning condenser unit. The dampness could be caused by a clogged roof gutter, improper grading, or a leaking hose bibb.

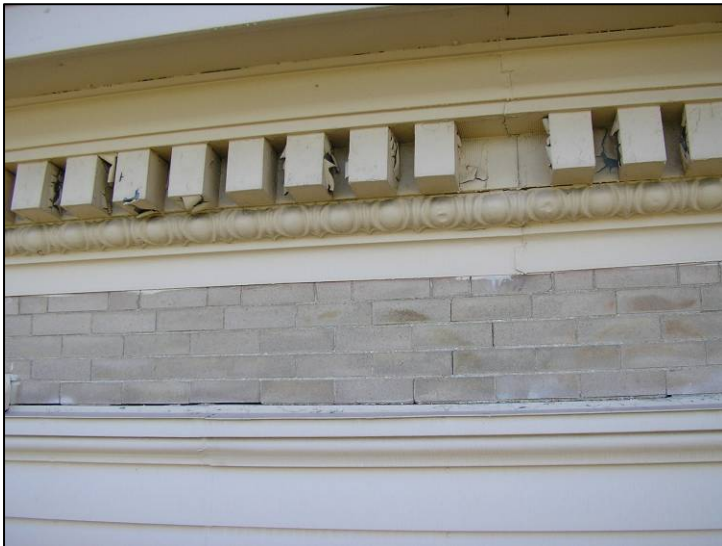
Building features such as these cornice dentils are important to maintain in order to avoid losing character-defining elements.

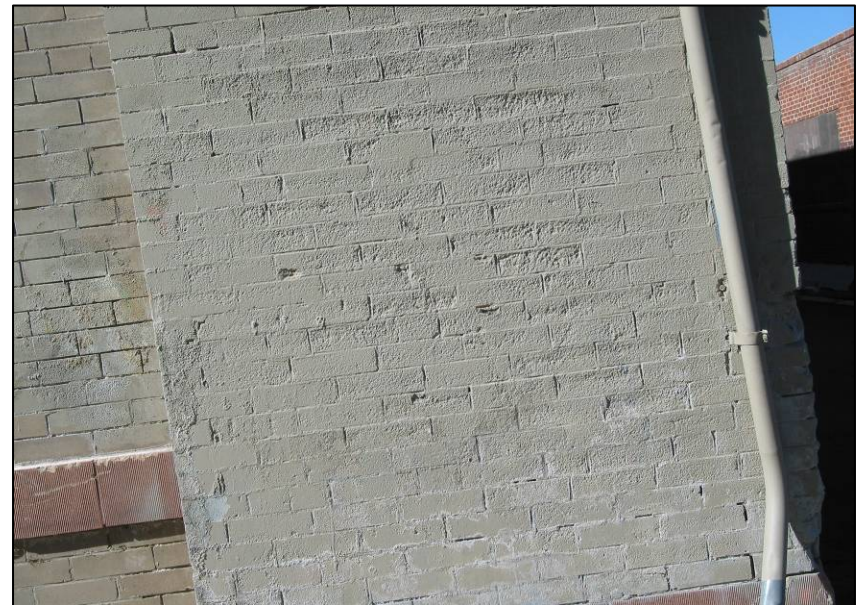
Destructive cleaning techniques such as sandblasting can damage masonry and other materials and should not be used.

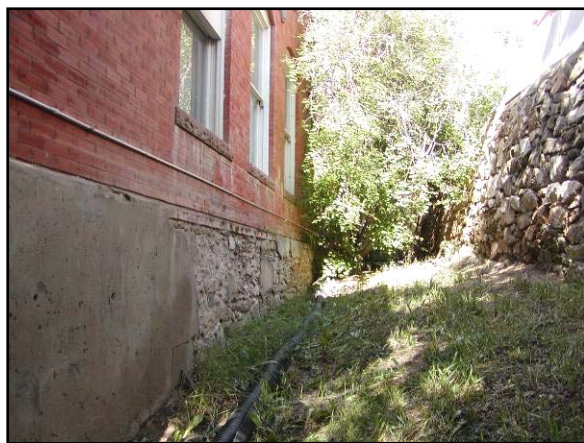
Ground that slopes towards the building foundation will bring unwanted moisture and should be addressed.

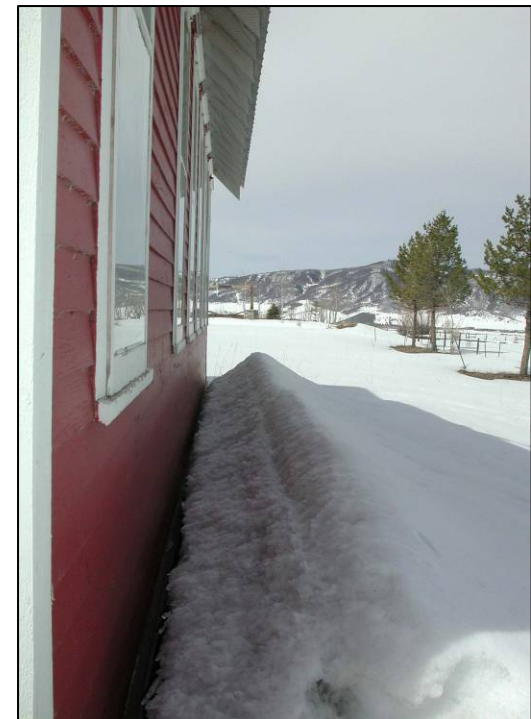
Sources of moisture, such as snow piles, should not be allowed to collect against foundation walls.

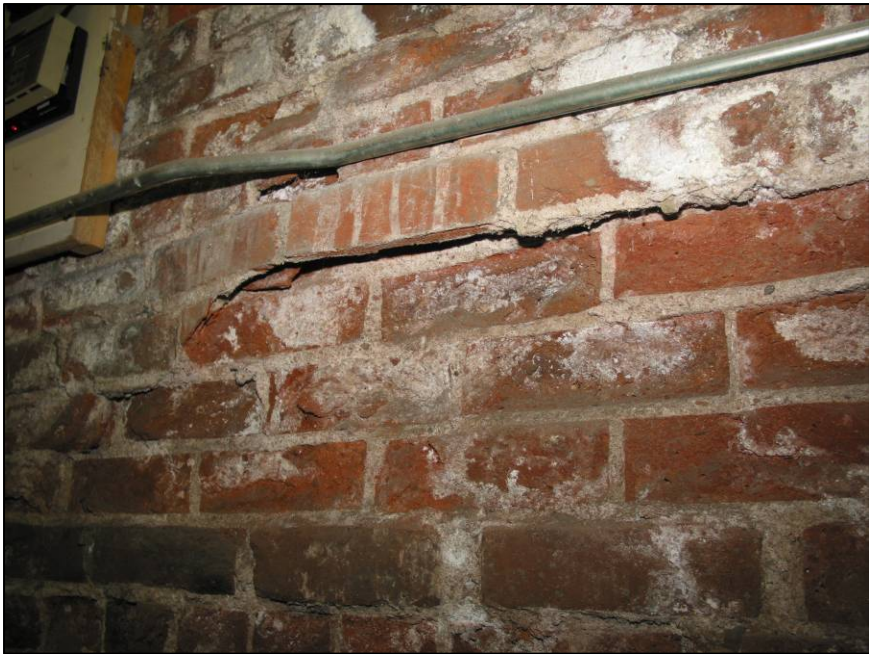
Efflorescence, a white chalky surface residue, indicates the presence of moisture and can cause significant deterioration of masonry.

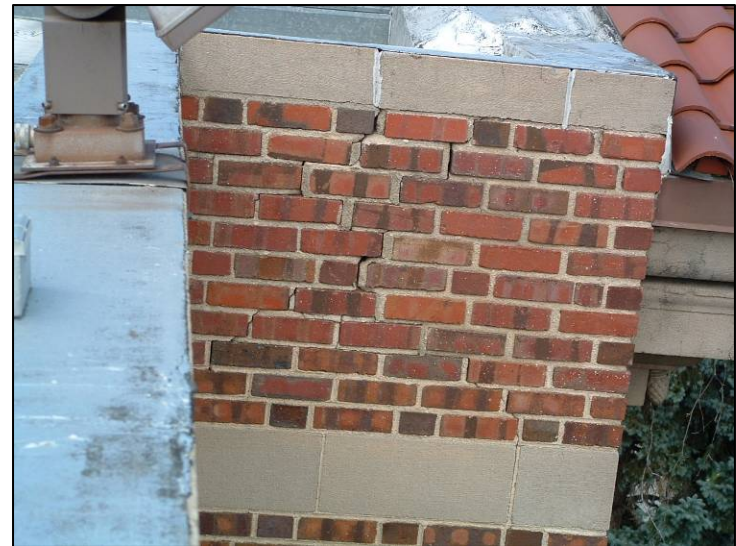
Masonry parapet walls are prone to moisture damage, such as deteriorated mortar joints, and should be examined regularly.

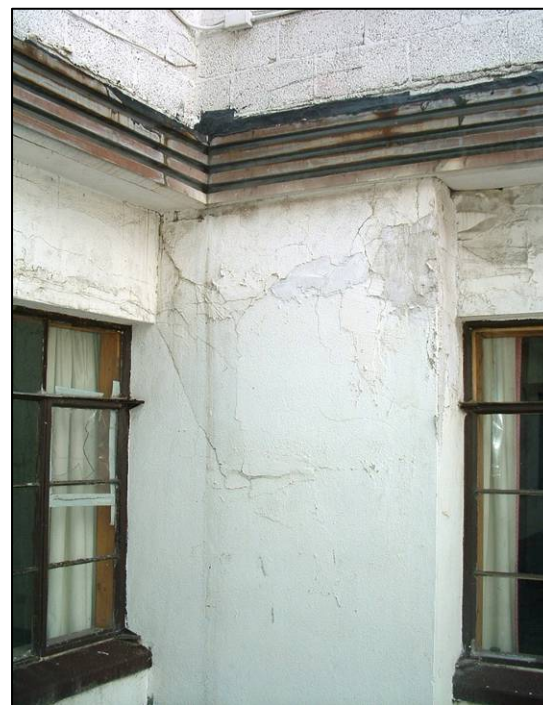
Cracks in stucco should be repaired to avoid moisture entering and enlarging them.

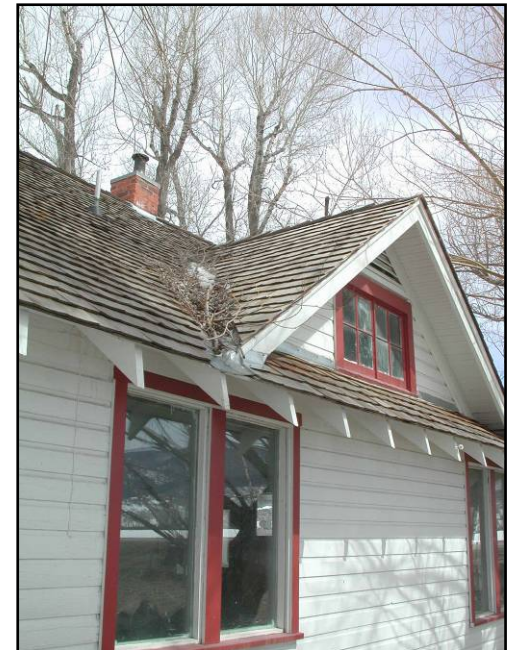
Dirt and debris should be removed promptly from all roof drainage systems.

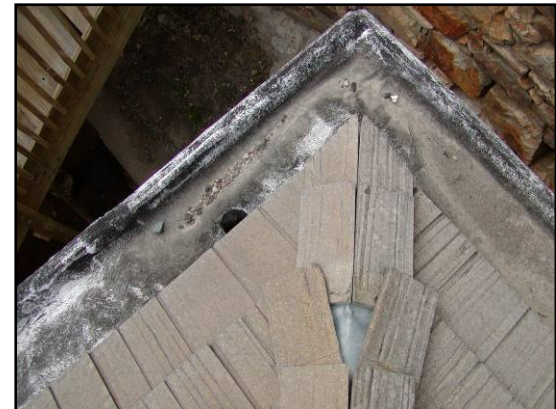
Missing or damaged shingles should be replaced as soon as possible.

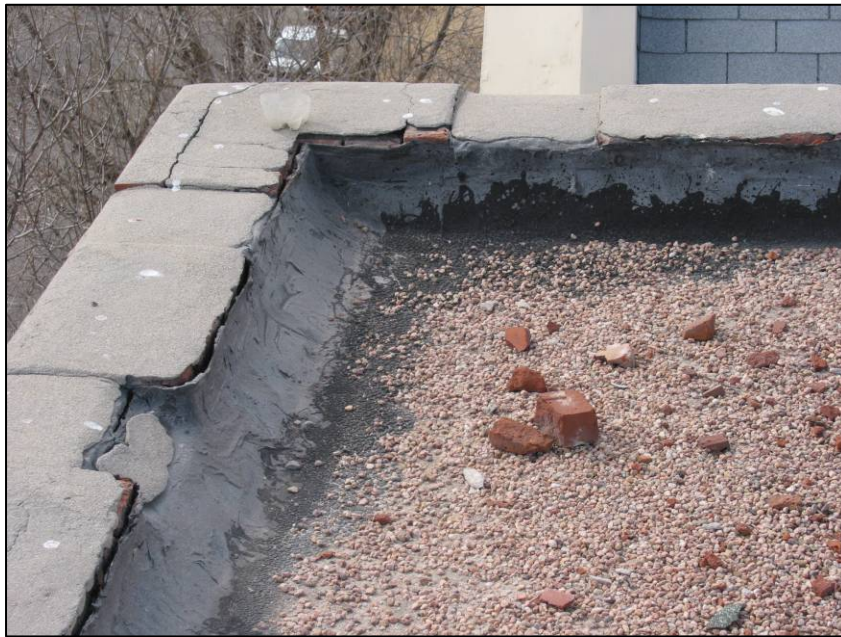
The failure of this built-up roof has allowed moisture to infiltrate along the parapet edge.

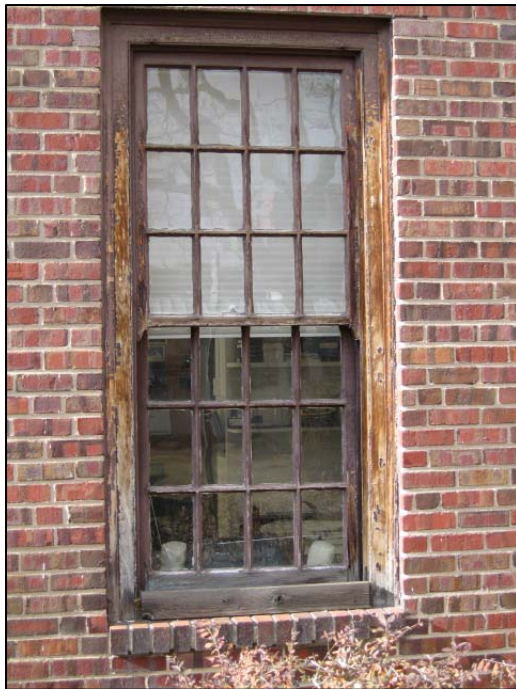
Lack of maintenance painting has caused this window to weather severely.

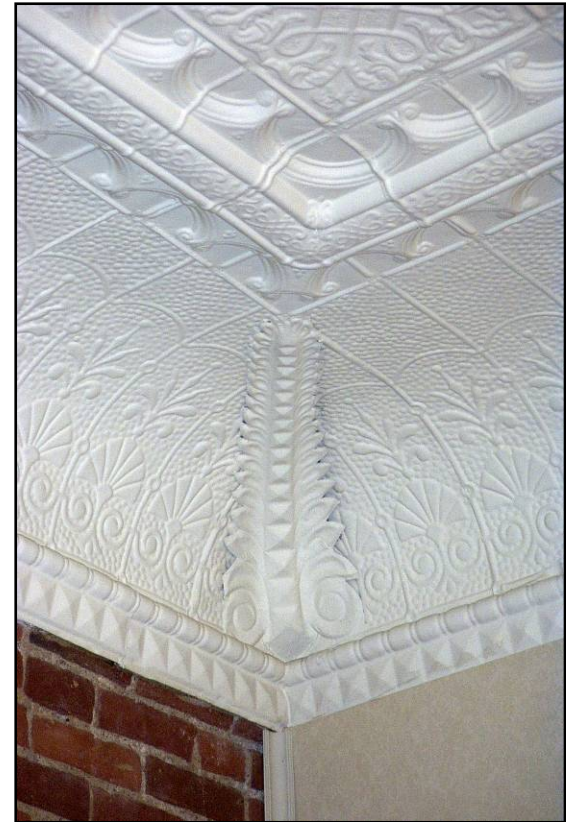
Tin ceilings should be checked for corrosion, staining, and other damage.

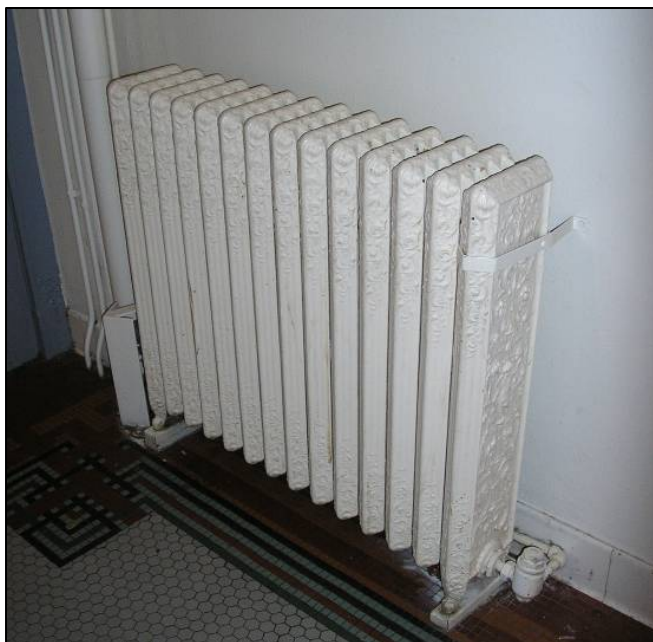
Prominent elements of historic mechanical systems, such as radiators, should be retained.

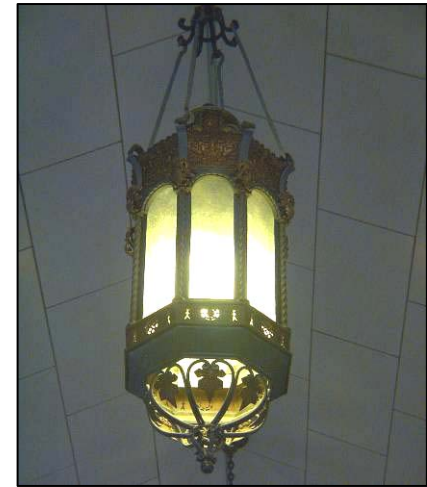
Original fixtures should be retained when updating electrical systems.
